# JOINT INVESTIGATION REPORT

INCIDENT NO: 1490236 JIV report S/N:

1. Spill incident Number: 1490236 2. Type of incident\* OIL SPILL  
3. Name of Location 24" TRANS-ESCRAVOS PIPELINE  
4. Name of nearest community SOKEBOLOU 5. State: DELTA 6. LGA BURUTU  
7. Type of Production facility/Installation OIL PIPELINE  
8. Asset owner/District THE SHELL PETROLEUM DEVELOPMENT COMPANY OF NIGERIA LIMITED / PIPELINE

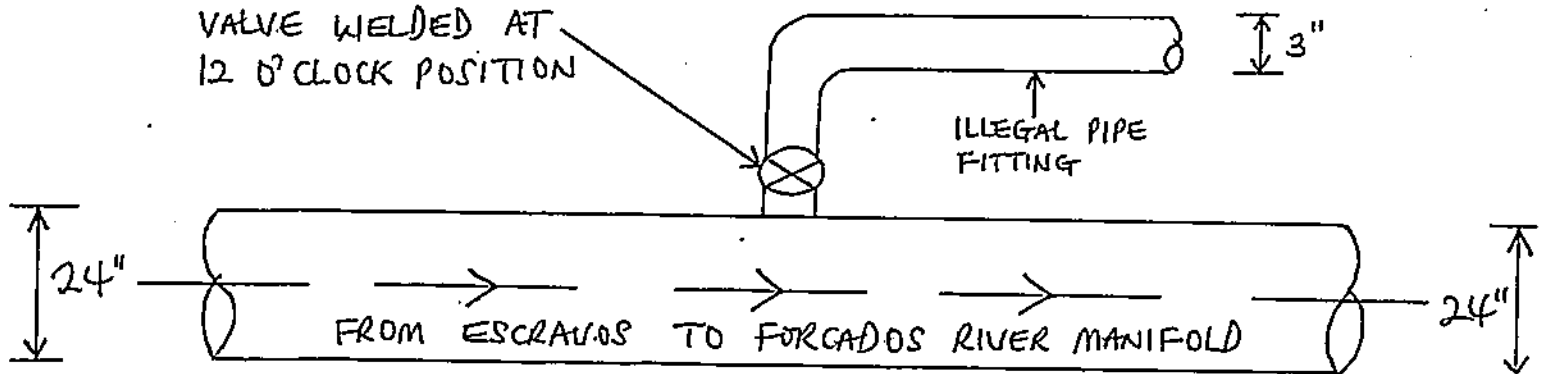
Additional observations around the spill point: ON EXCAVATION, THE JOINT INVESTIGATION TEAM SAW A 4" VALVE WITH PIPE FITTING, ILLEGALLY ATTACHED TO THE 24" TRANS-ESCRAVOS PIPELINE AT 12 O'CLOCK POSITION. THE LEAK WAS FROM THE 3" PIPE FITTING.

SECTION OF 24" TRANS-ESCRAVOS PIPELINE AT SOKEBOLU SHOWING; POSITION OF CRUDE THEFT POINT AT 12 O' CLOCK POSITION

4" FAILED ILLEGAL HOT-TAP VALVE WELDED AT 12 O' CLOCK POSITION
