# JOINT INVESTIGATION REPORT

INCIDENT NO: 1692296 JIV report S/N:

1. Spill incident Number: 1692296 2. Type of incident\* OIL SPILL  
3. Name of Location 24" TRANS-RAMOS PIPELINE  
4. Name of nearest community ODIMODI 5. State: DELTA 6. LGA BURUTU  
7. Type of Production facility/Installation OIL PIPELINE  
8. Asset owner/District THE SHELL PETROLEUM DEVELOPMENT COMPANY OF NIGERIA LIMITED / PIPELINE

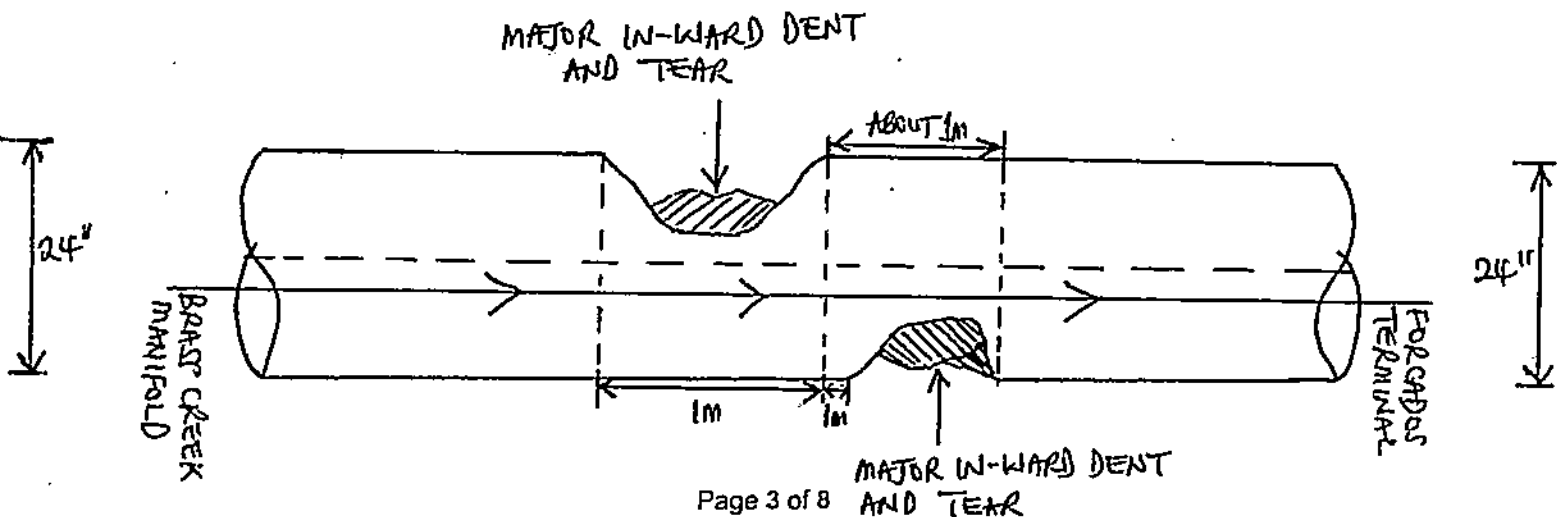
Additional observations around the spill point: INCIDENT CAUSE WAS CONFIRMED AS THIRD PARTY INTERFERENCE, ESTABLISHED ON EXCAVATION OF THE LEAK POINTS. A MAJOR IN-WARD DENT AND TEAR (AT 12 O'CLOCK AND 6 O'CLOCK POSITIONS RESPECTIVELY) DUE TO EXTERNAL IMPACT WERE OBSERVED ON THE PIPELINE.

SECTION OF 24" TRANS - RAMOS PIPELINE AT ODIMODI AXIS, SHOWING MAJOR IN-WARD DENT AND TEAR AT 12 O'CLOCK AND 6 O'CLOCK POSITIONS RESPECTIVELY
