JOINT INVESTIGATION REPORT

INCIDENT NO: 1771360 JIV report S/N: Nº 0000223

1. Spill incident Number: 1771360 2. Type of incident* OIL SPILL
3. Name of Location 28" BOMU - BONNY PIPELINE
4. Name of nearest community BODO-CITY 5. State: RIVERS 6. LGA GOKANA
7. Type of Production facility/Installation OIL PIPELINE
8. Asset owner/District THE SHELL PETROLEUM DEVELOPMENT COMPANY OF NIGERIA LIMITED/ PIPELINE

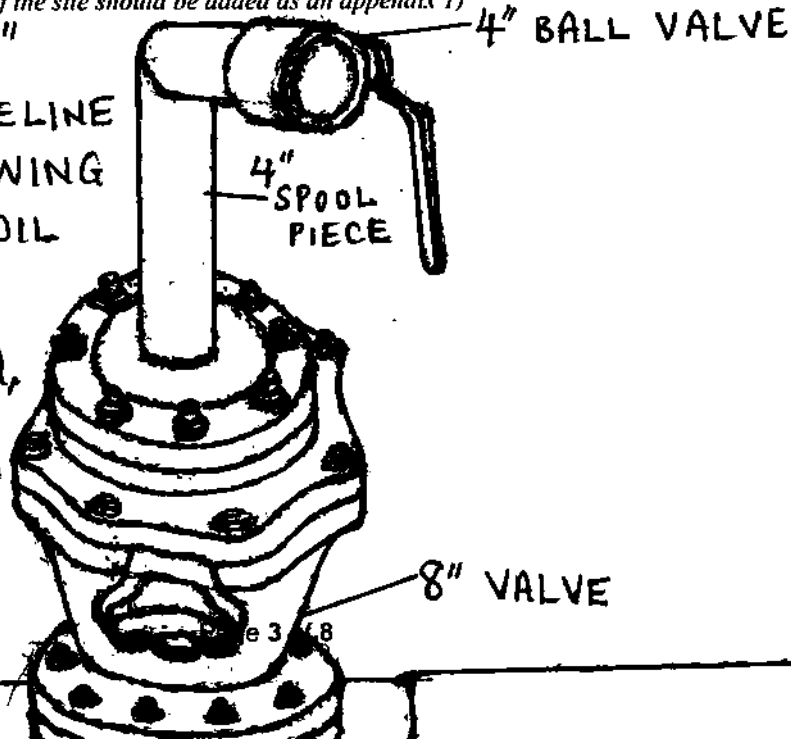
Additional observations around the spill point: **THE SPILL OCCURRED AT THE SAME LOCATION AS A PREVIOUS INCIDENT (REFERENCE NO. 1382376) WHICH HAD ITS THEN-OBSERVED CRUDE OIL THEFT FITTING BLIND-FLANGED BY THE ASSET OWNER. TODAY, ANOTHER ILLEGAL FITTING WAS OBSERVED BY THE JOINT INVESTIGATION TEAM ON THE SAME BLIND POINT. THE TEAM NOTICED AN EXISTING COFFERDAM HITHERTO BUILT BY THE ASSET OWNER.**

SECTION OF 28" BOMU - BONNY PIPELINE AT BODO-CITY SHOWING ONE (1) NO. CRUDE OIL THEFT POINT AT 12 O' CLOCK POSITION, INSTALLED BY UNKNOWN PERSON(S).

RECOVERY OF FREE-PHASE OIL WAS BEING DONE AND REPAIR ON THE AFFECTED PIPELINE SECTION WAS BEING PLANNED BY BLIND-FLANGING.
