JOINT INVESTIGATION REPORT

INCIDENT NO: 1571105 JIV report S/N: No 0000131

1. Spill incident Number: 1571105 2. Type of incident* OIL SPILL
3. Name of Location 6" MININGIA - AHA BULLIC LINE
4. Name of nearest community AKYABU 5. State: RIVERS 6. LGA EMOLGA
7. Type of Production facility/Installation BULLIC LINE
8. Asset owner/District SPDC / LAND 2.

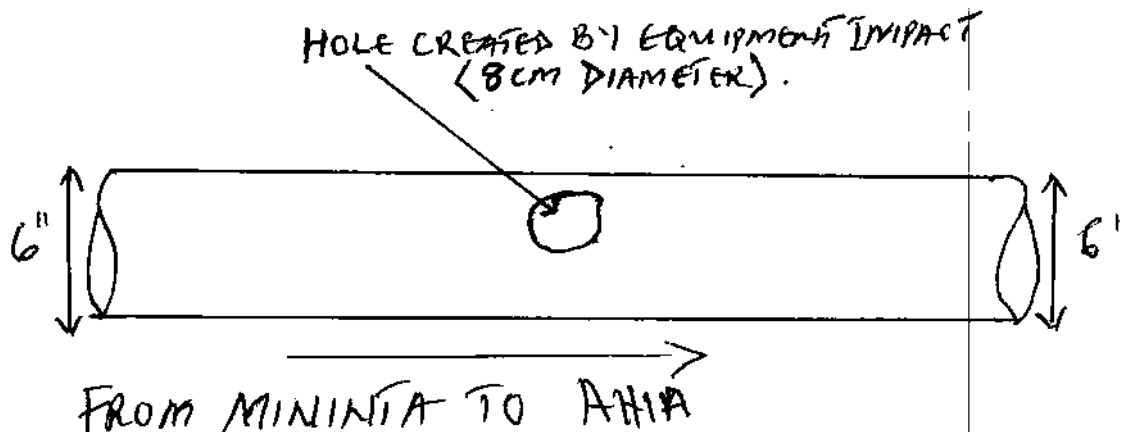
Additional observations around the spill point: ON ARRIVAL AT SITE, THE JOINT INVESTIGATION TEAM OBSERVED OIL AND WATER BUBBLING AT SPILL POINT. FARMLAND PREPARATION (PLOUGHING) WAS ALSO NOTICED.

SECTION OF 6" MININTIA - AHA BULK LINE AT AKPABU SHOWING POSITION OF ACCIDENTAL 3RD PARTY EQUIPMENT IMPACT AT 9 TO 10 O'CLOCK POSITION.

RECOVERY ACTIVITIES ONGOING
 REPAIR WORKS PLANNED
