JOINT INVESTIGATION REPORT

INCIDENT NO: 1578624 JIV report S/N:

1. Spill incident Number: 1578624 2. Type of incident* OIL SPILL
3. Name of Location BELEMA WELL 1L FLOWLINE (4" FLOWLINE)
4. Name of nearest community BELEMA 5. State: RIVERS 6. LGA AKUKU-TORU
7. Type of Production facility/Installation FLOWLINE
8. Asset owner/District THE SHELL PETROLEUM DEVELOPMENT COMPANY OF NIGERIA LIMITED.

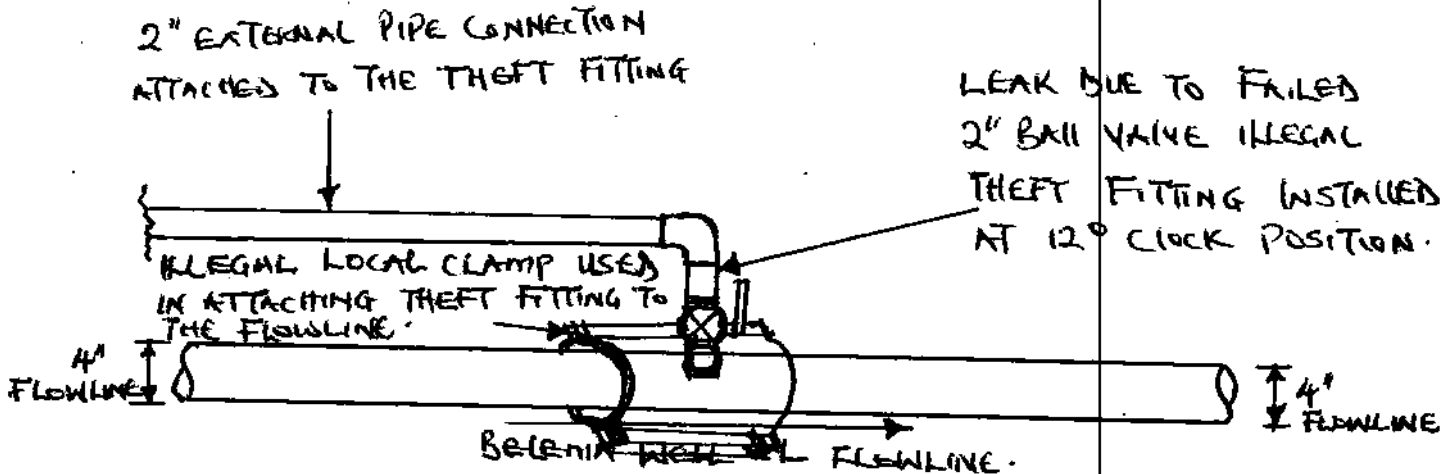
Additional observations around the spill point: A LOCAL CLAMP WAS USED TO INSTALL THE THEFT FITTING, WHILE OIL AND GAS BUBBLES WERE OBSERVED DURING JOINT INVESTIGATION VISIT.

| <input checked="" type="checkbox"/> Failed Weld-on illegal hot tap valve | <input type="checkbox"/> Failed Clamp, | <input type="checkbox"/> Missing Pipeline/Flowline |
| <input checked="" type="checkbox"/> Crude oil theft (illegal bunkering) point, | <input type="checkbox"/> Saver-pit over flow | <input type="checkbox"/> Third party tampering with Clamp |

SECTION OF VIEW OF BELEMA WELL 1L 4" FLOWLINE AT BELEMA.
SHOWING FAILED CRUDE OIL THEFT FITTING

REPAIR WORK PLANNED.
