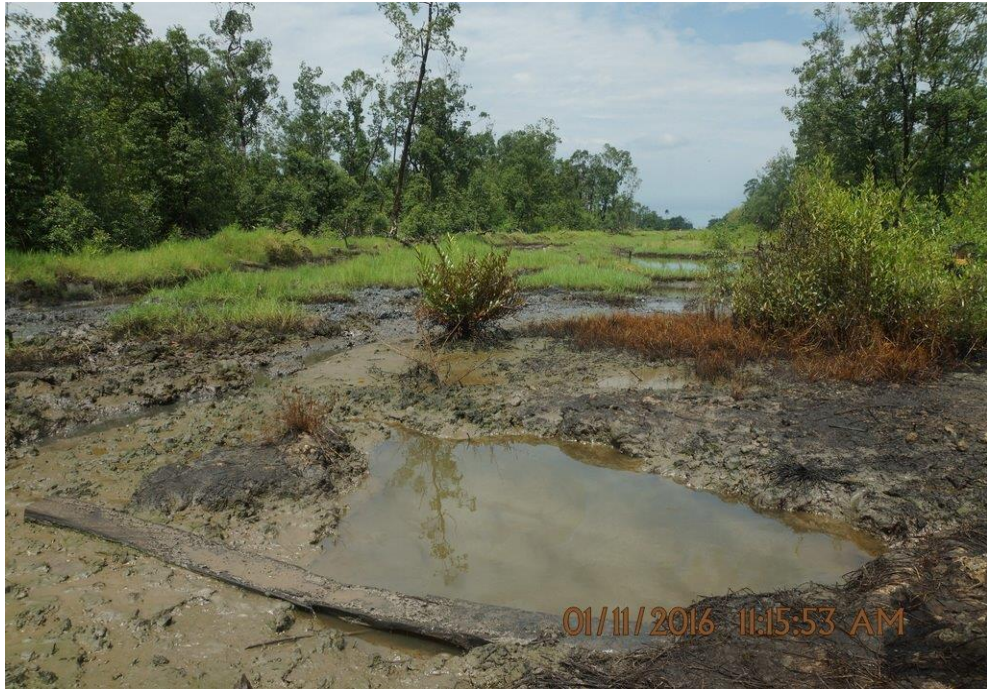
Overview: Part of spill impact on 20" Otumara-Escravos Pipeline Right of Way at Ugboegungun. Picture was taken during Joint Investigation of 1<sup>st</sup> November 2016.

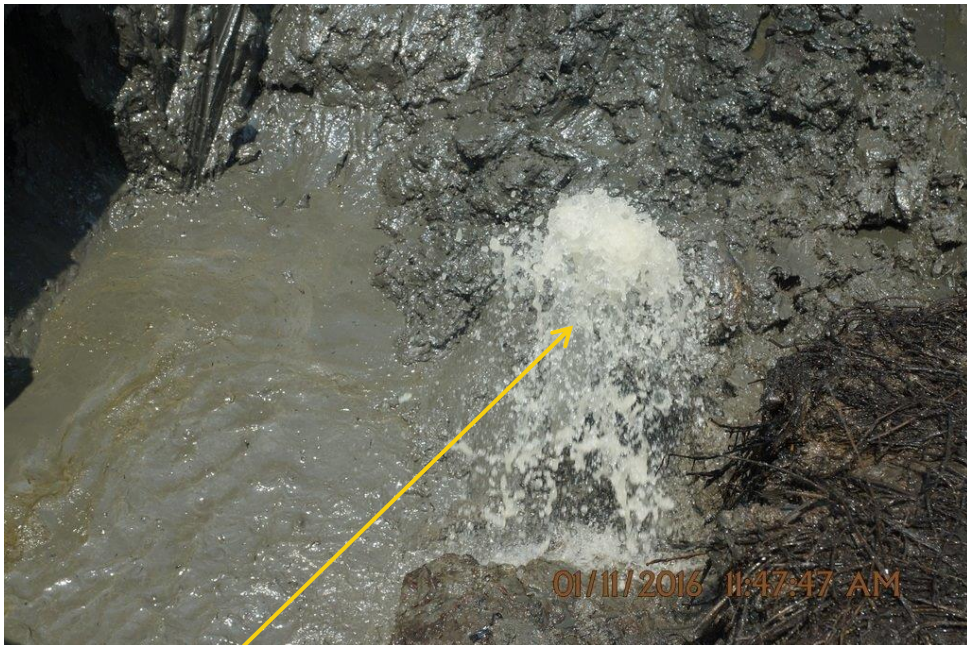
Close-up: Oily Water bubbling out from Illegal Fitting on 20" Otumara-Escravos Pipeline at Ugboegungun. Picture was taken during Joint Investigation of 1<sup>st</sup> November 2016.
