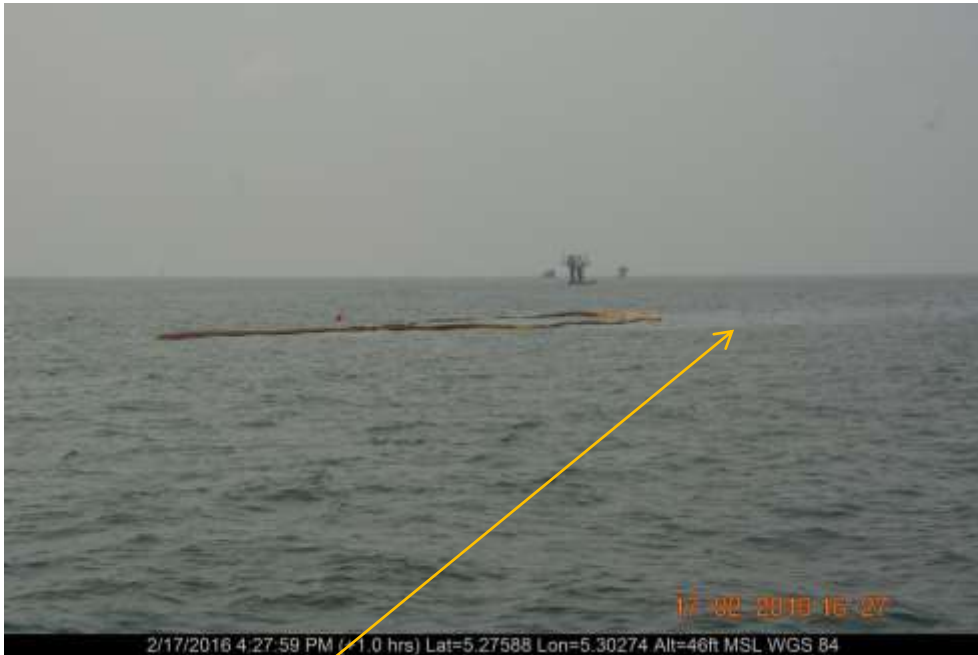
Overview: Containment boom and oil slick observed around the leak point on 48" Forcados Terminal Export Line. Picture was taken during Joint Investigation of 17th February 2016.

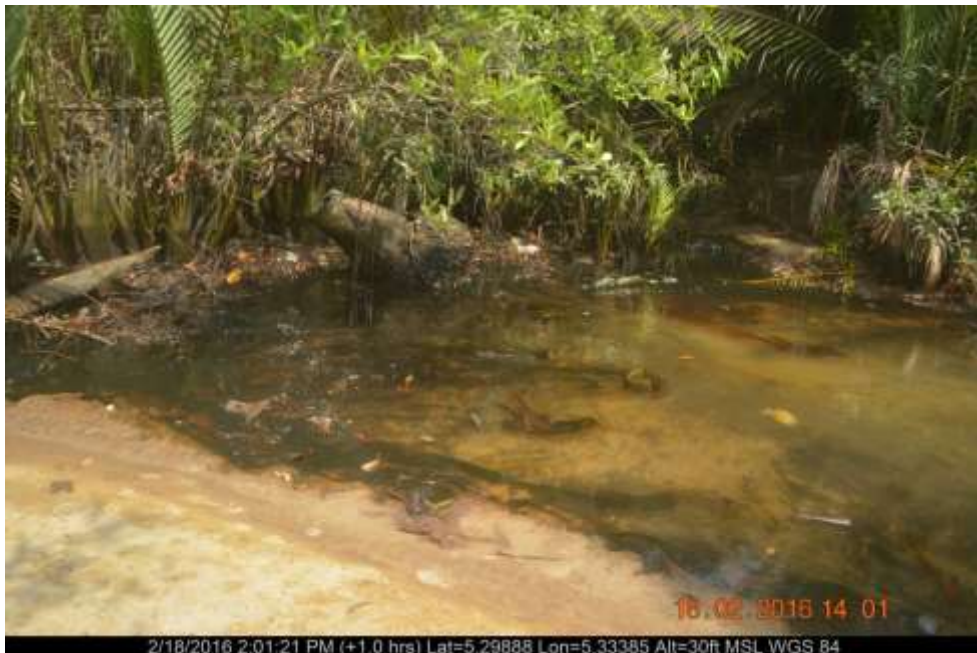
Overview: Part of spill impact from 48" Forcados Terminal Export Line. Picture was taken during Joint Investigation of 18th February 2016.

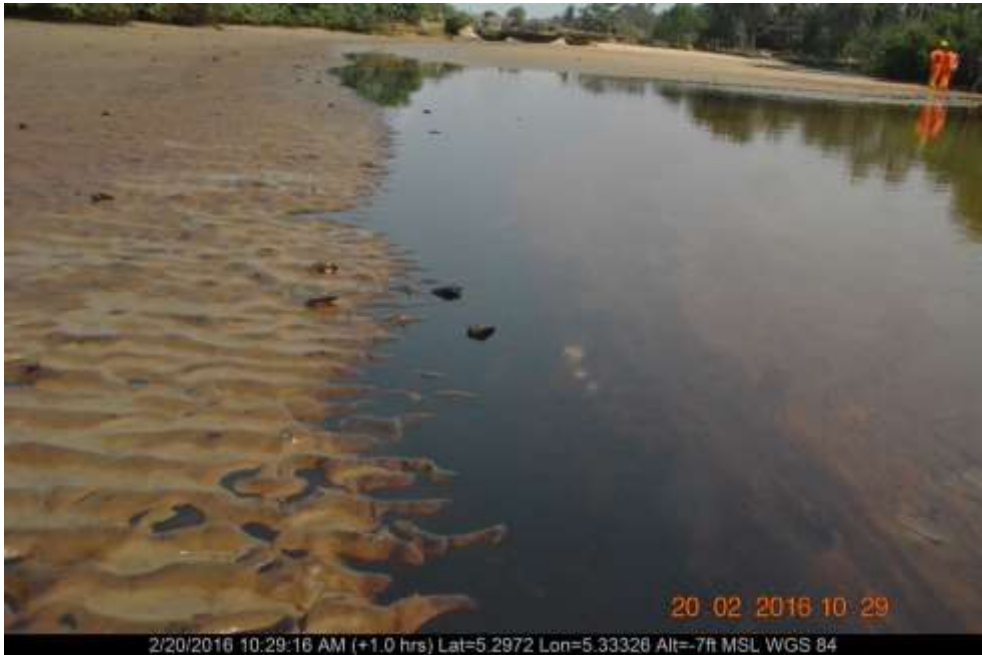
Overview: Part of spill impact from 48" Forcados terminal Export Line. Picture was taken during Joint Investigation of 20th February 2016.

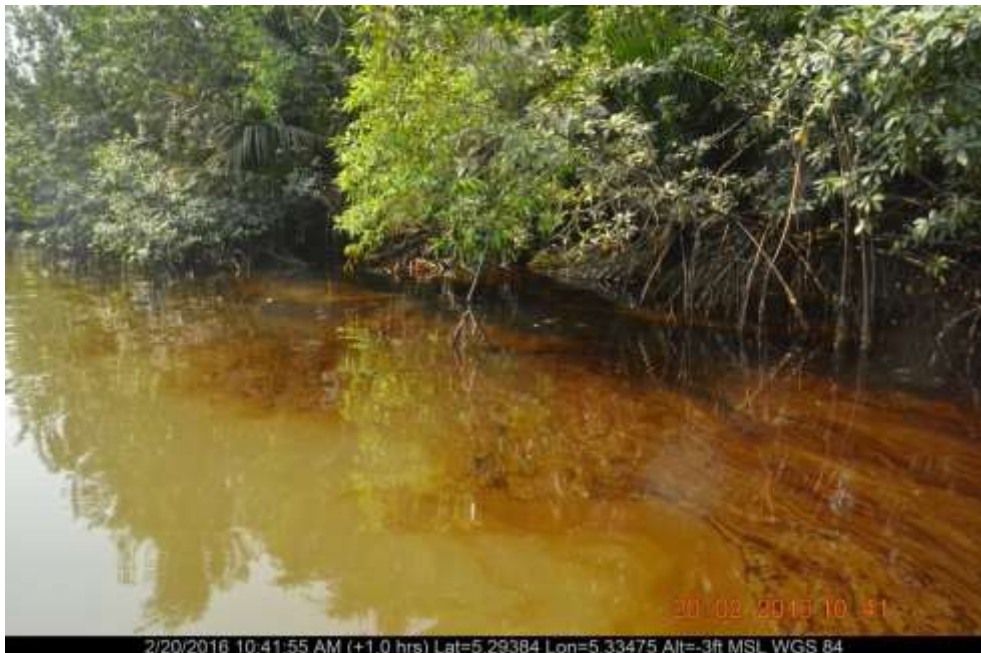
Overview: Part of spill impact from 48" Forcados terminal Export Line. Picture was taken during Joint Investigation of 20th February 2016.
