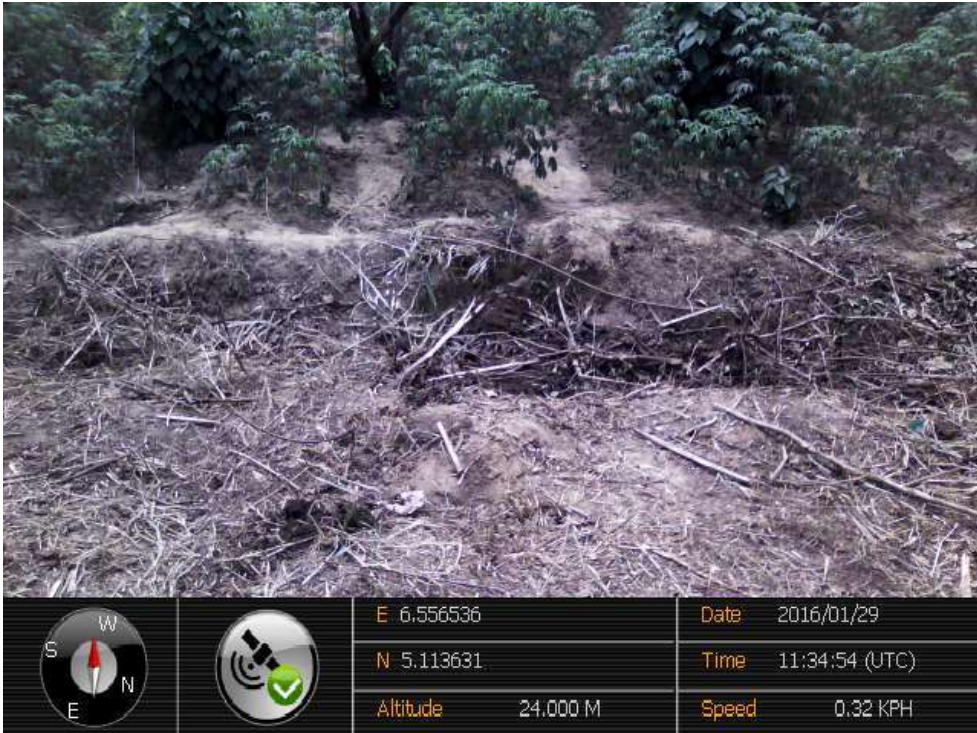
**Overview:** Part of spill impact on Ubie Well5LS Flowline Right of Way at Idu Ekpeye. Picture was taken during Joint Investigation of 29<sup>th</sup> January 2016.

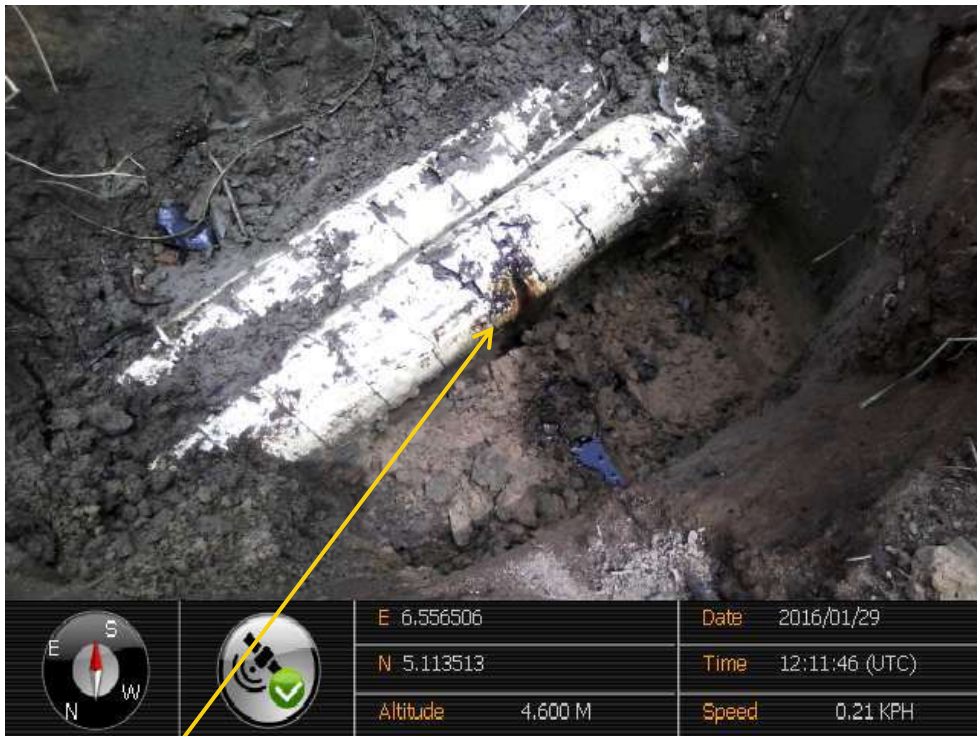
**Close-up:** Hacksaw cut (Point 1) on Ubie Well5LS Flowline at Idu Ekpeye. Picture was taken during Joint Investigation of 29<sup>th</sup> January 2016.

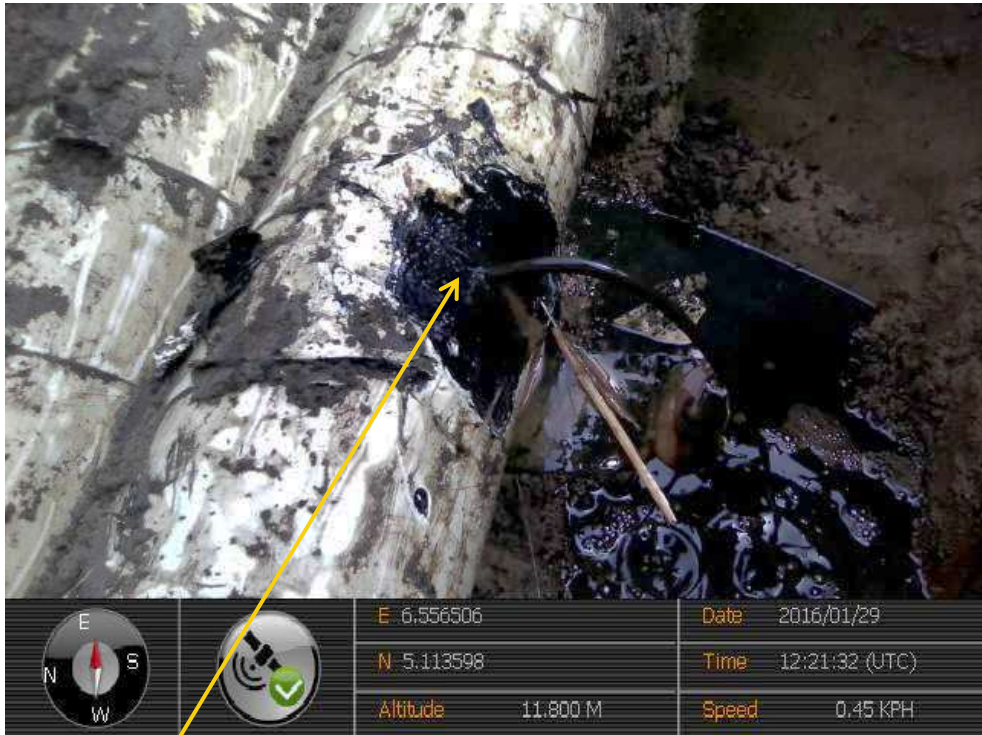
Close-up: Hacksaw cut (Point 2) on Ubie Well5LS Flowline at Idu Ekpeye. Picture was taken during Joint Investigation of 29<sup>th</sup> January 2016.
