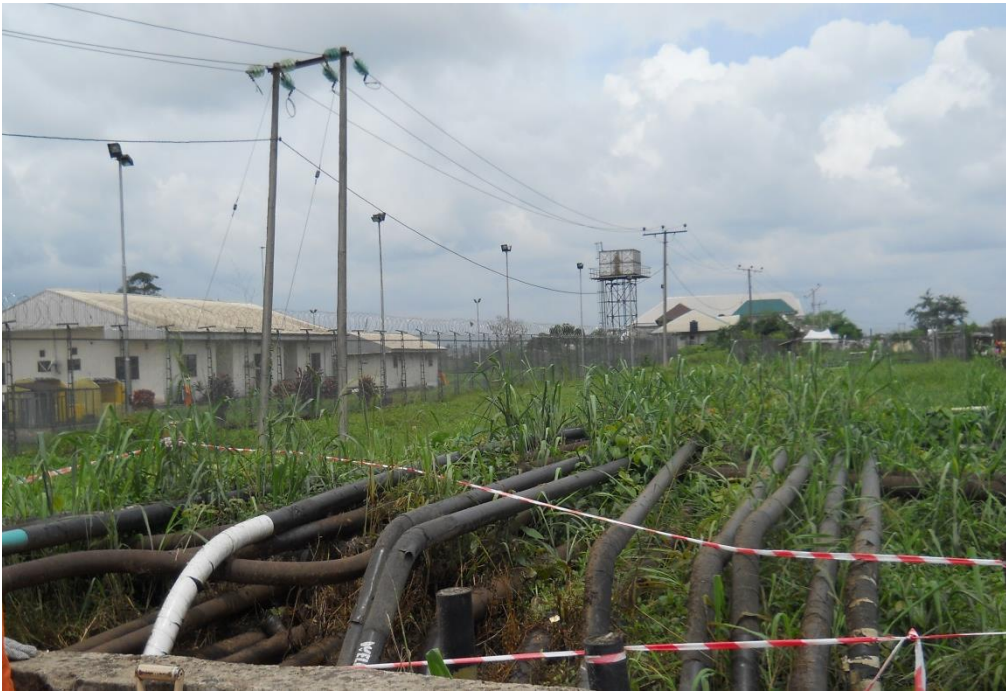
Overview: Part of spill impact on Obigbo North Well 26T_18S_20T_three disused Flowlines at Umuwalia. Picture was taken during Joint Investigation of 21st July 2016.

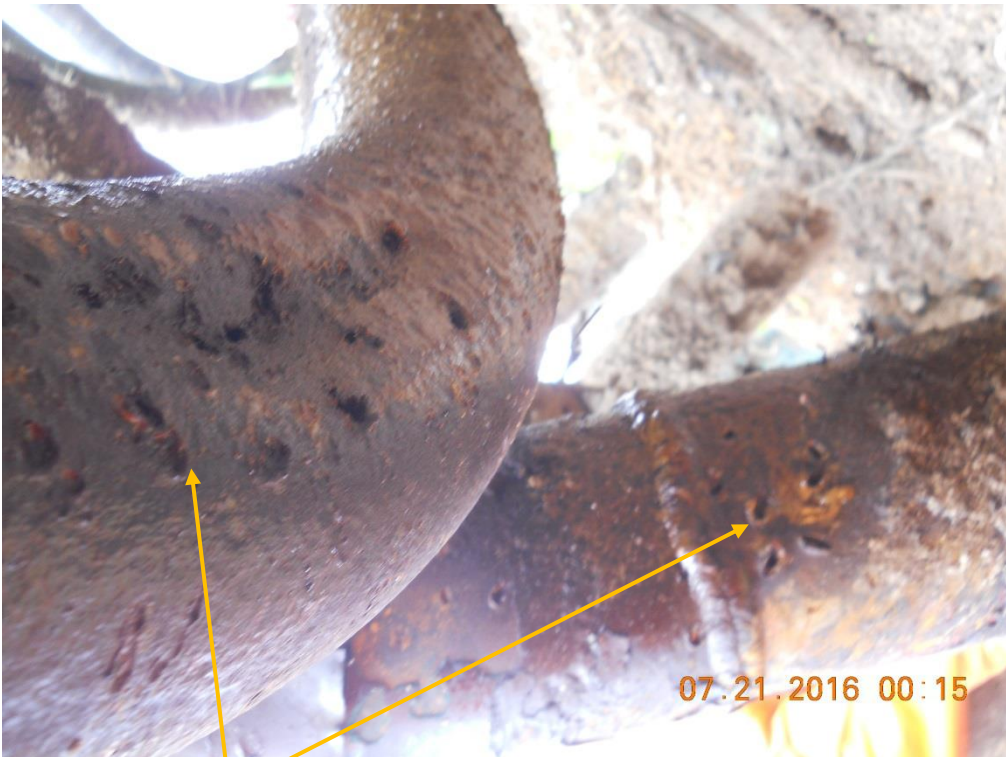
Close-up: Irregular holes and Marks on Obigbo North Well 26T_18S Flowlines at Umuwalia. Picture was taken during Joint Investigation of 21st July 2016.
