JOINT INVESTIGATION REPORT

INCIDENT NO: 1675064 JIV report S/N: NO: 0000179

1. Spill incident Number: 1675064 2. Type of incident* OIL SPILL
3. Name of Location OBIGBO NORTH WELL 2ST, 18S, 20T AND THREE (3) OTHER DISUSED FLOWLINES.
4. Name of nearest community UMUWALIA 5. State: RIVERS 6. LGA OYIGBO
7. Type of Production facility/Installation OIL FLOWLINE
8. Asset owner/District SPDC / LAND 1

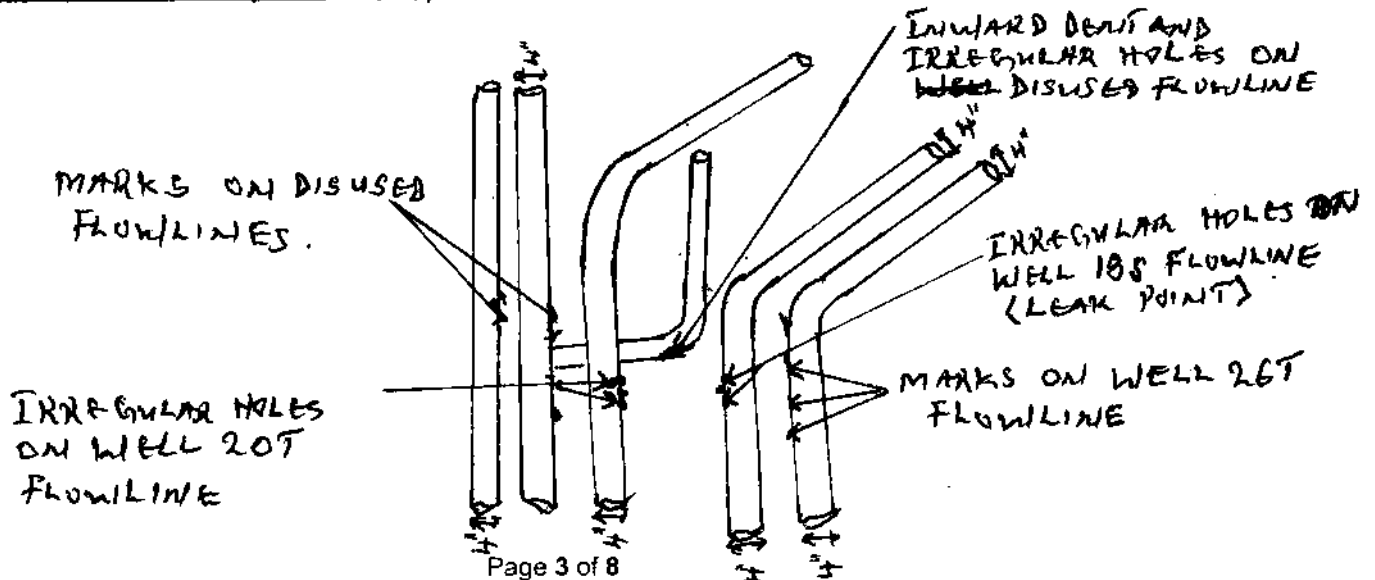
Additional observations around the spill point: ON ARRIVAL AT SITE, THE JOINT INVESTIGATION AND TEAM OBSERVED PIECES OF CONCRETE AND RUBBER BELT SUSPECTED TO HAVE BEEN USED BY UNKNOWN PERSON(S) TO SECURE EXPLOSIVE MATERIAL WHICH CAUSED IMPACT (IRREGULAR HOLES, INWARD DENT, AND MARKS) TO THE OBIGBO NORTH WELL FLOWLINES.

Others (specify) IRREGULAR HOLES AND MARKS DUE TO SUSPECTED EXPLOSIVE MATERIAL.

SECTION OF ORIGINAL NORTH WELL 26T, 18S, 20T AND THREE (3) OTHER DISUSED FLOWLINES AT UMULAZI SHOWING THE IMPACT DUE TO SUSPECTED EXPLOSIVE MATERIAL.

REPAIR WORK PLANNED
