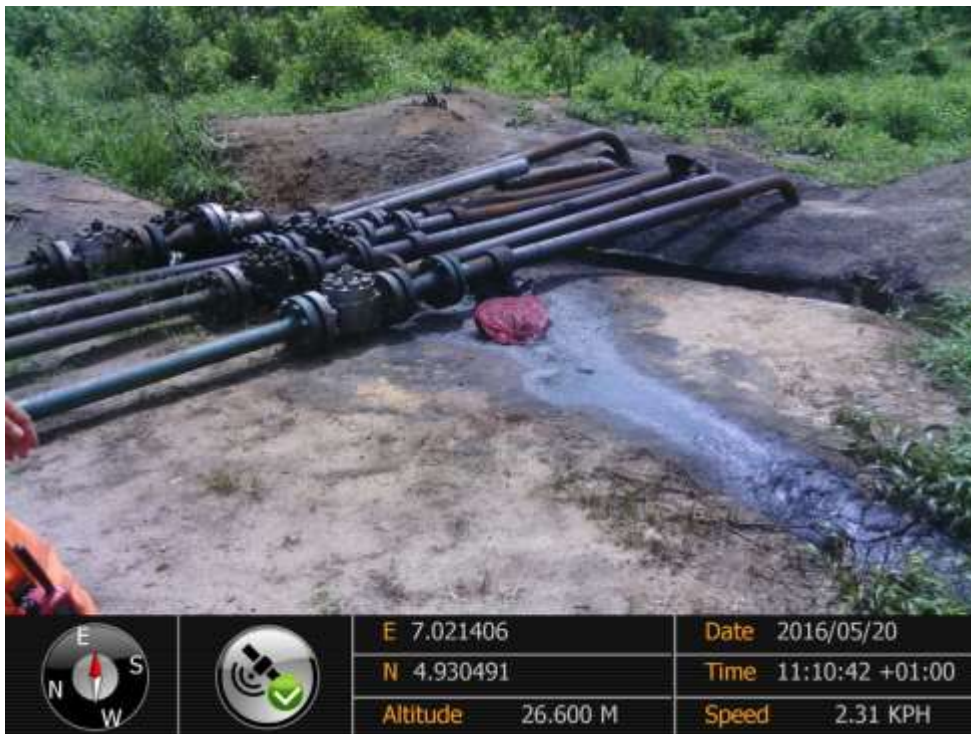
Overview: Part of Spill Impact on Agbada2 Well 41/42/43 Cluster Right of Way at Omuohia/Omuokoji. Picture was taken during Joint Investigation of 20<sup>th</sup> May 2016.

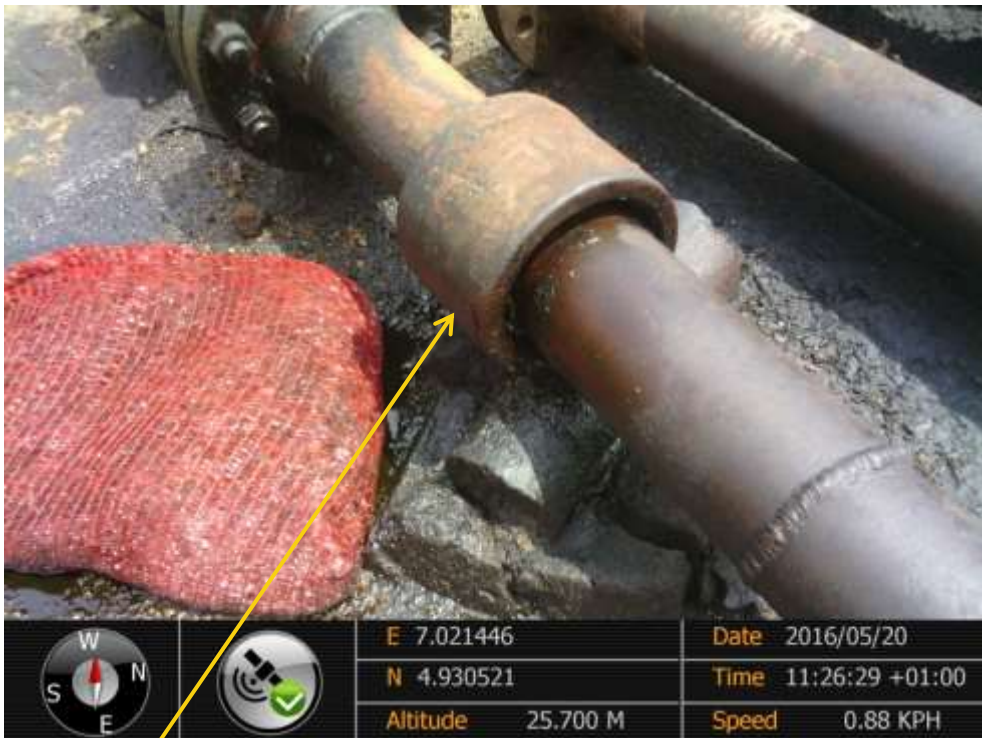
Close-up: Cathodic Leak joint damaged by fire on Agbada2 Well 41/42/43 Cluster at Omuohia/Omuokoji. Picture was taken during Joint Investigation of 20<sup>th</sup> May 2016.

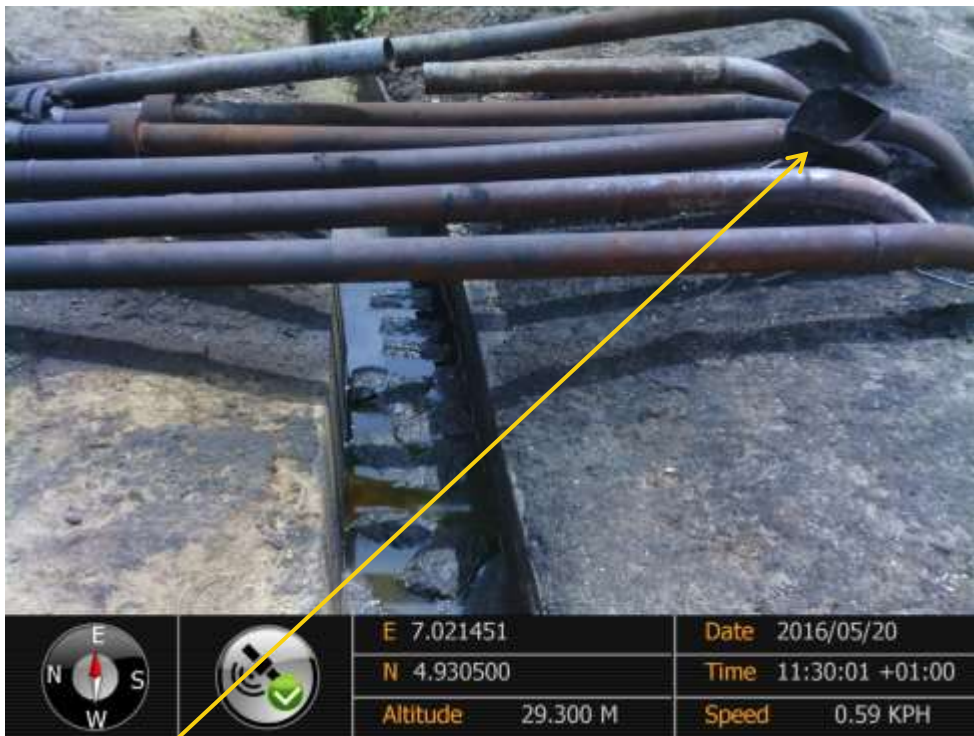
Close-up: Damaged Flowline on Agbada2 Well 41/42/43 Cluster at Omuohia/Omuokoji.  
Picture was taken during Joint Investigation of 20<sup>th</sup> May 2016.
