Overview: Part of spill impact on Bonny Terminal tank15-10'' drainline flange at Bonny. Picture was taken during Joint Investigation of 1st December 2016.

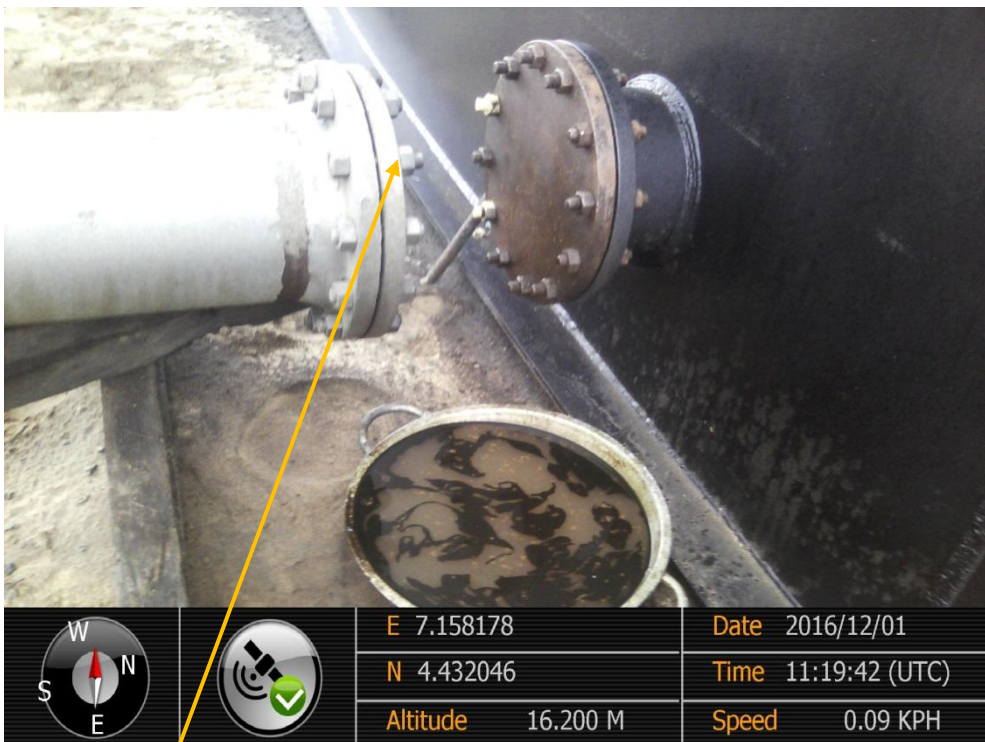
Close-up: Leaking flange on Bonny Terminal tank15-10'' drainline flange at Bonny. Picture was taken during Joint Investigation of 1st December 2016.
