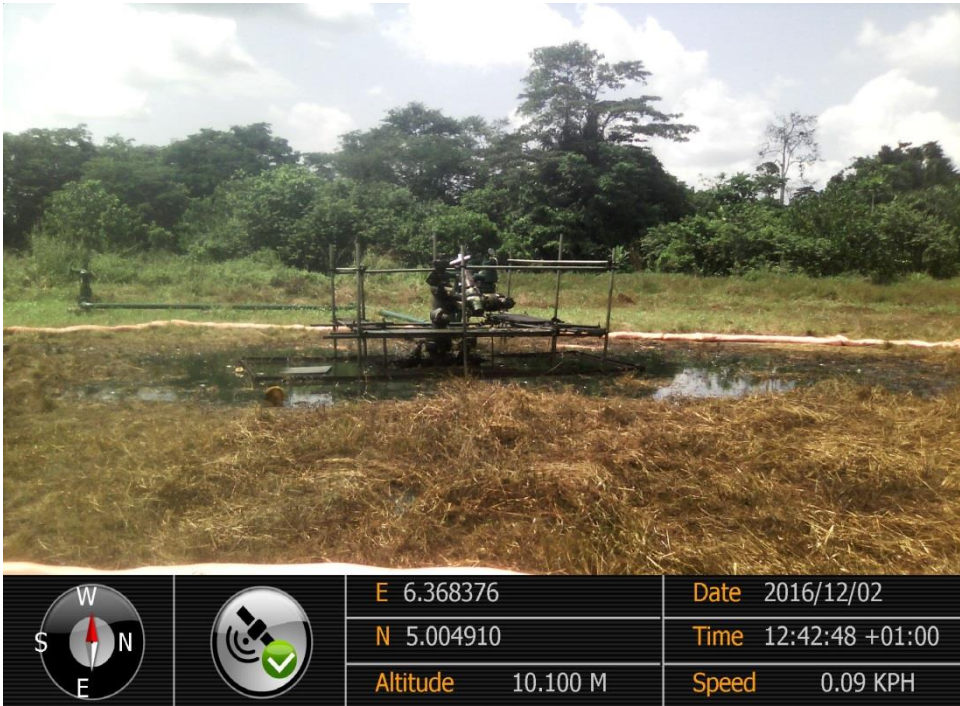
Overview: Part of spill impact on Etelebou Well-11T Well head at Akenfa. Picture was taken during Joint Investigation of 2nd December 2016.

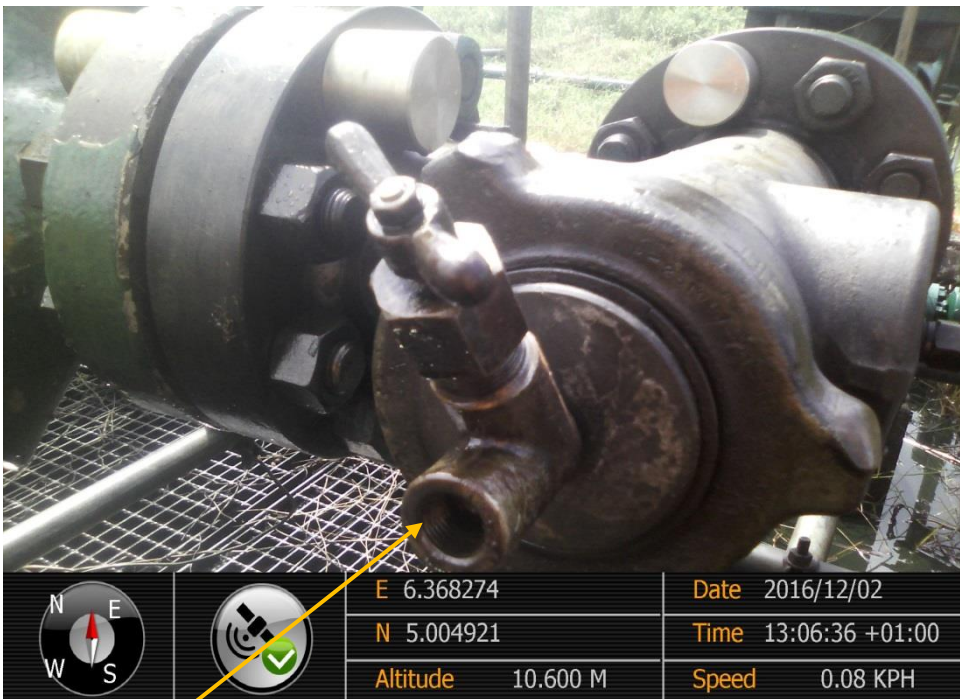
Close-up: Tampered Cork valve on Etelebou Well-11T Well head at Akenfa. Picture was taken during Joint Investigation of 2nd December 2016.
