# JOINT INVESTIGATION REPORT

INCIDENT NO: 1742185 JIV report S/N: N<sup>o</sup> 0000184

1. Spill incident Number: 1742185 2. Type of incident\* OIL SPILL  
3. Name of Location 18" ASSA - RUMUEKYE PIPELINE  
4. Name of nearest community EGBEDA 5. State: RIVERS 6. LGA EMOHUA  
7. Type of Production facility/Installation OIL PIPELINE  
8. Asset owner/District SPDC / PIPELINE

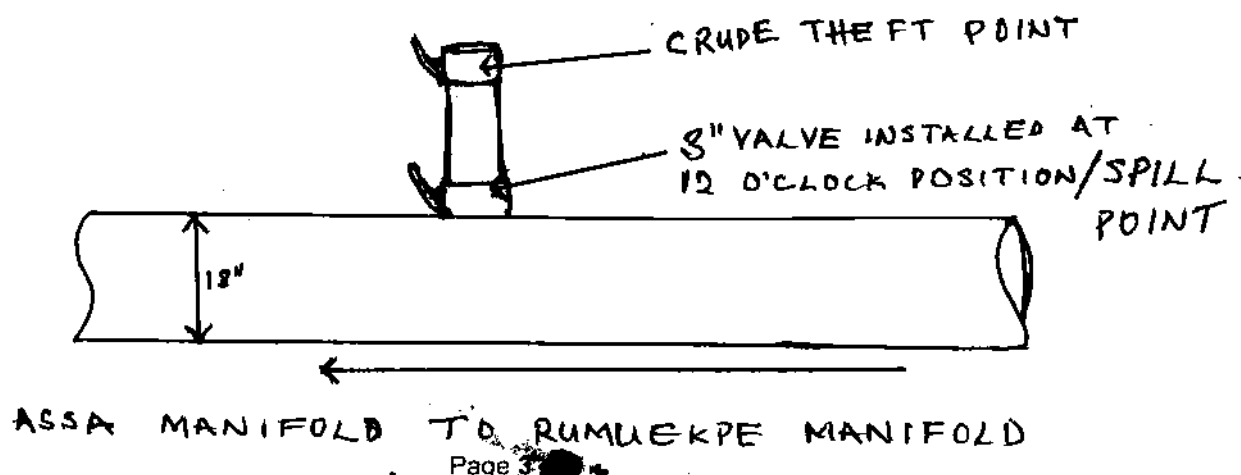
JOINT INVESTIGATION TEAM OBSERVED A HOSE CONNECTED TO THE CRUDE OIL THEFT POINT AT SITE.

| <input checked="" type="checkbox"/> Failed Weld-on illegal hot tap valve | <input type="checkbox"/> Failed Clamp, | <input type="checkbox"/> Missing Pipeline/Flowline |
| <input checked="" type="checkbox"/> Crude oil theft (illegal bunkering) point, | <input type="checkbox"/> Saver-pit over flow | <input type="checkbox"/> Third party tampering with Clamp |

SECTION OF 18" ASSA - RUMUEKPE PIPELINE AT EGBEDA SHOWING POSITION OF CRUDE OIL THEFT POINT AS
