# JOINT INVESTIGATION REPORT

INCIDENT NO: 1749924 JIV report S/N: 0981

1. Spill incident Number: 1749924 2. Type of incident\* OIL SPILL  
3. Name of Location 16" NUNRIVER - KOLOCREEK PIPELINE  
AGBURA  
4. Name of nearest community OTUOKPOTI 5. State: BAYELSA LGA TENAGOA/OGBIA  
7. Type of Production facility/Installation OIL PIPELINE  
8. Asset owner/District SPDC / PIPELINE

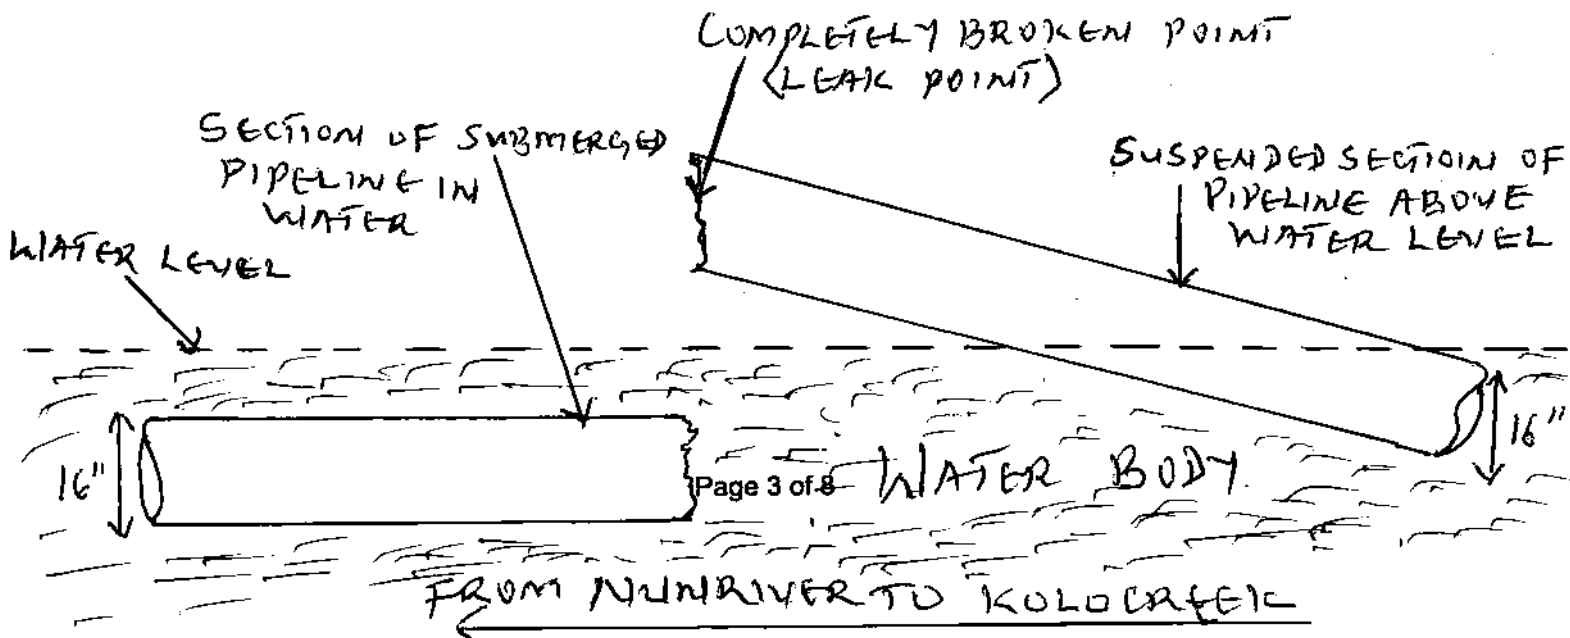
Additional observations around the spill point: JOINT INVESTIGATION TEAM (JIT) OBSERVED THAT THE INCIDENT OCCURED AT A RIVER CROSSING AND TOOK MORE THAN A YEAR TO ACCESS THE LEAK POINT. JIT ALSO OBSERVED THAT THE PIPELINE WAS TOTALLY SUBMERGED IN WATER. A SECTION OF COMPLETELY BROKEN OF THE PIPELINE WAS SUSPENDED.

SECTION OF 16" MUNRIVER - KOLOCREEK PIPELINE AT AGBURA / OTUOKPOT SHOWING POSITION OF COMPLETELY BROKEN POINT.
