Overview: Part of spill impact on Kanbo Wells - 7L/S and 9T Wellheads Cluster at Agbidiana. Picture was taken during Joint Investigation of 27th October 2016.

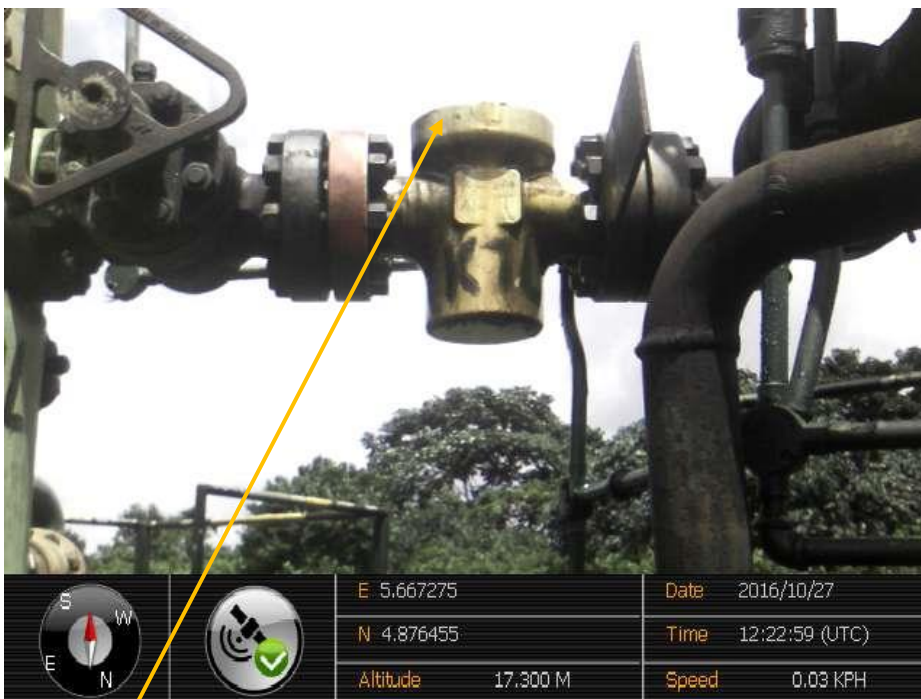
Close-up: Position of stolen CCU actuator on Kanbo Wells - 7L/S and 9T Wellheads Cluster at Agbidiana. Picture was taken during Joint Investigation of 27th October 2016.

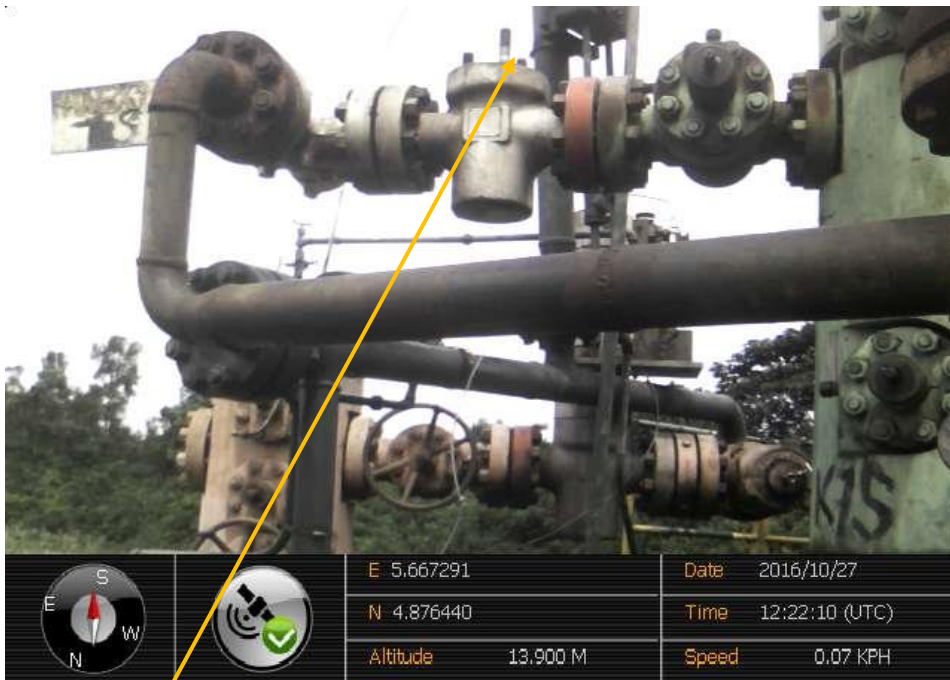
Close-up: Position of stolen CCU actuator on Kanbo Wells - 7L/S and 9T Wellheads Cluster at Agbidiana. Picture was taken during Joint Investigation of 27th October 2016.

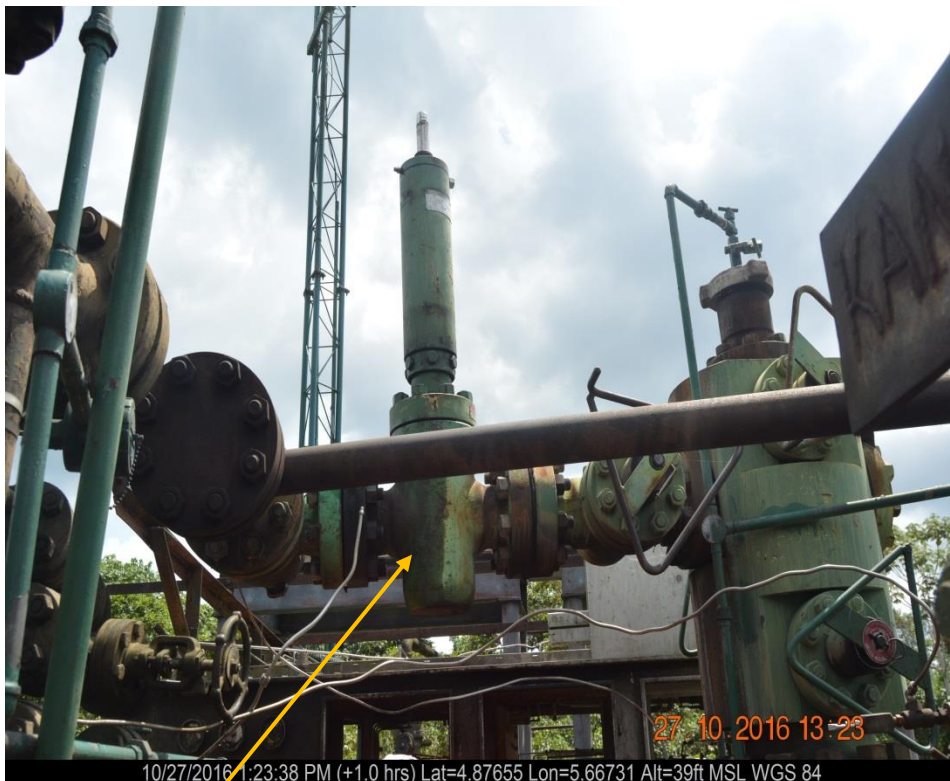
Close-up: Tampered CCU actuator on Kanbo Wells - 7L/S and 9T Wellheads Cluster at Agbidiana. Picture was taken during Joint Investigation of 27th October 2016.
