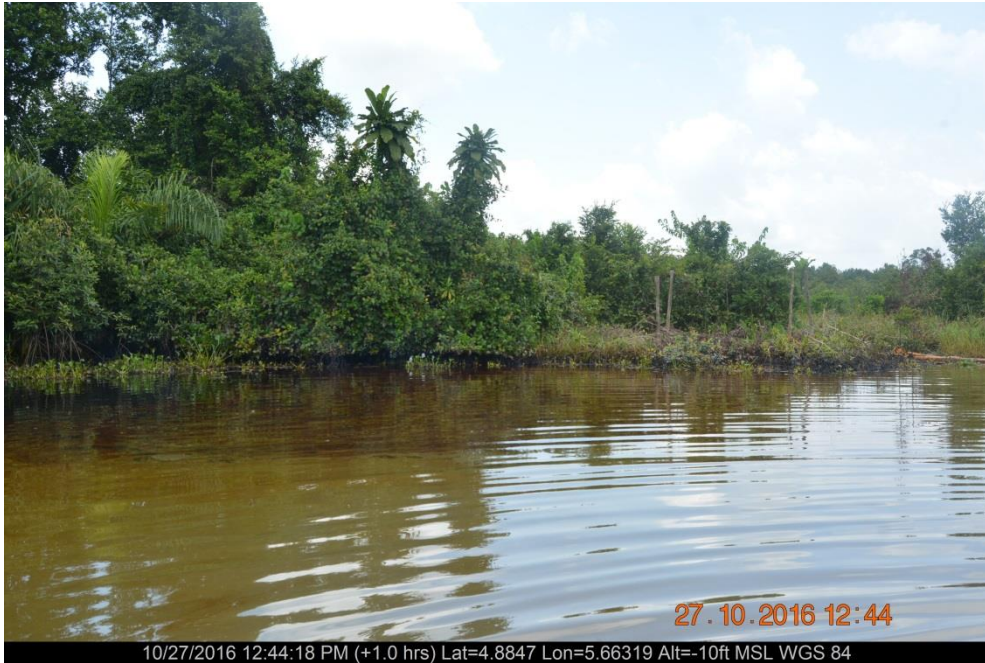
Overview: Part of spill impact on 6" Kanbo Well 6T Flowline at Agbidiama. Picture was taken during Joint Investigation of 27<sup>th</sup> October 2016.

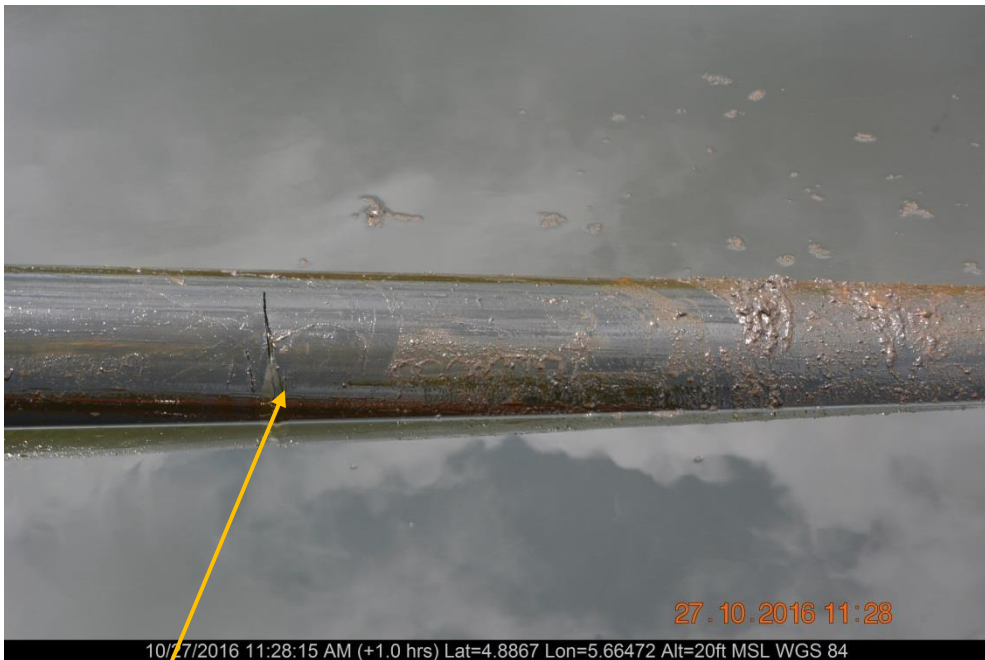
Close-up: Hacksaw cut on 6" Kanbo Well 6T Flowline at Agbidiama. Picture was taken during Joint Investigation of 27<sup>th</sup> October 2016.

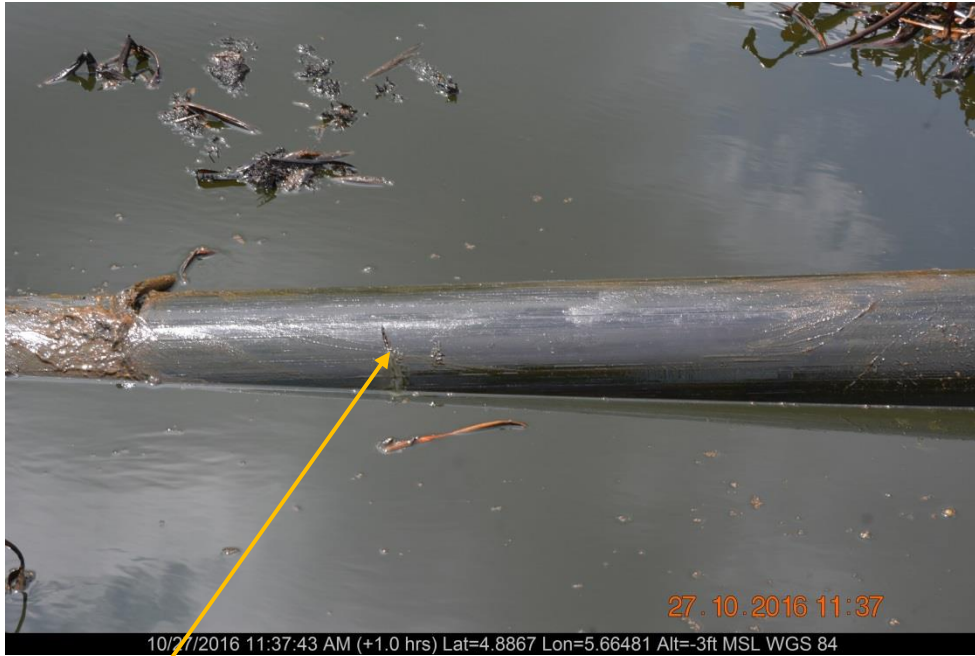
Overview: Hacksaw cut on 6" Kanbo Well 6T Flowline at Agbidiana. Picture was taken during Joint Investigation of 27<sup>th</sup> October 2016.
