# JOINT INVESTIGATION REPORT

INCIDENT NO: 1707836 JIV report S/N: Nº 0000090

1. Spill incident Number: 1707836 2. Type of incident\* OIL SPILL  
3. Name of Location 8" NKALI - IMO RIVER 2 PIPELINE (BREATHING TUBE BOX)  
4. Name of nearest community UMURU-OKHARA State: RIVERS 6. LGA ETCHE  
7. Type of Production facility/Installation 8" PIPELINE BREATHING TUBE BOX  
8. Asset owner/District THE SHELL PETROLEUM DEVELOPMENT COMPANY OF NIGERIA LIMITED | PIPELINE

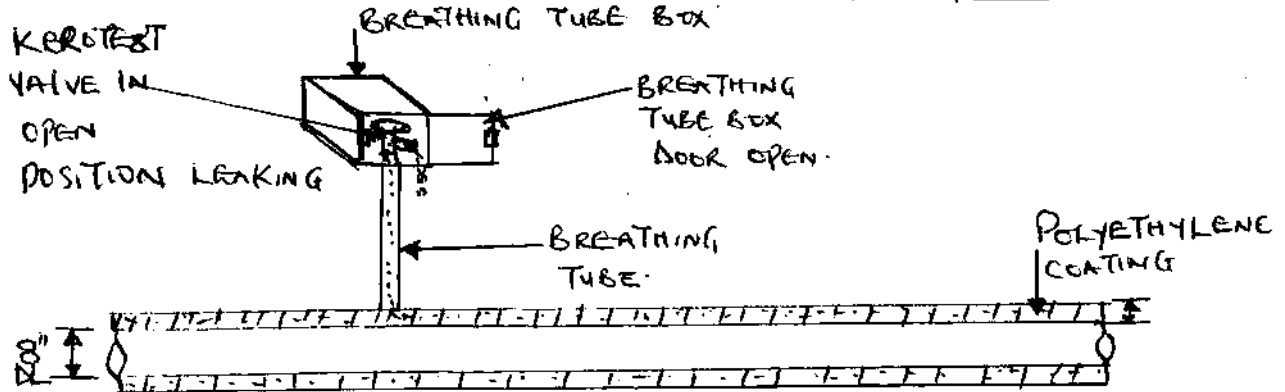
Additional observations around the spill point: ON ARRIVAL AT THE INCIDENT SCENE, THE JOINT INVESTIGATION TEAM OBSERVED THAT THE KEROTEST VALVE WAS LEAKING AND LEFT IN AN OPEN POSITION BY UNKNOWN PERSON(S). ON TURNING OFF THE KEROTEST VALVE, THE LEAK STOPPED.

SECTIONAL VIEW OF 8" NKALI - IMO RIVER 2 PIPELINE (BREATHING TUBE)

AT UMURDU - OKWARA (ODAGWA) SHOWING - THIRD PARTY

TAMPERING WITH KEROTEST VALVE

MOPPING OF N&N - RECOVERABLE AND REPAIR WORK INITIATED AND COMPLETED.
