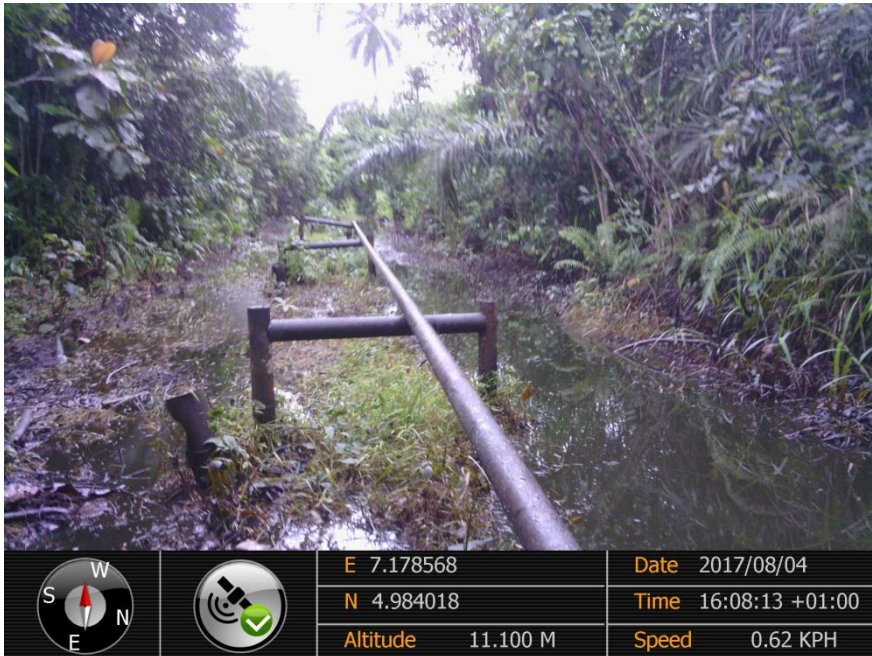
Overview: Part of spill impact on Imo River 1 Well 5S Flowline Right of Way at Igiriukwu. Picture was taken during Joint Investigation of 4th Aug 2017.

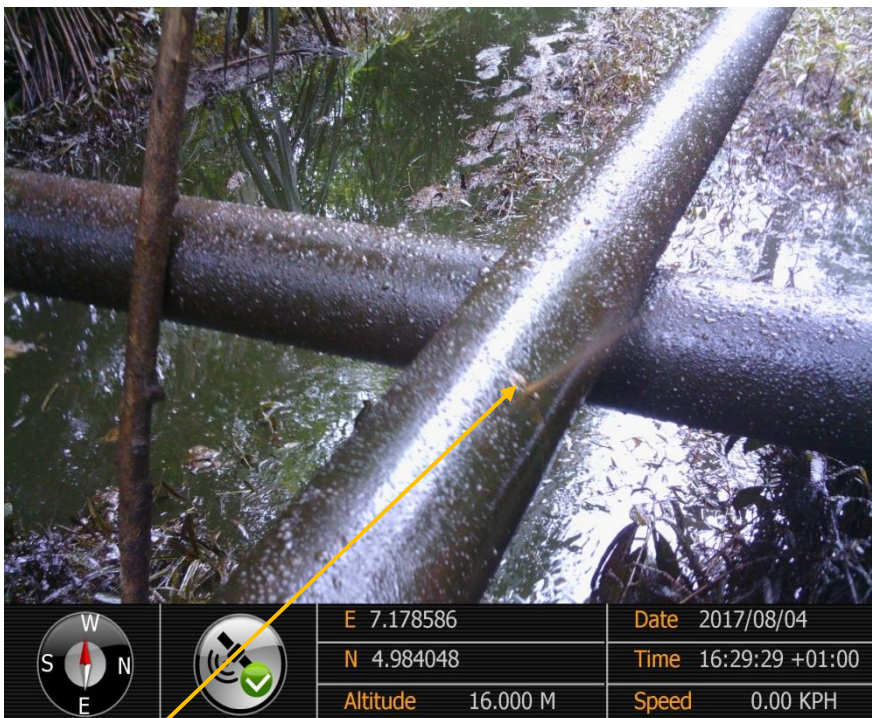
Close-up: Hacksaw Cut on Imo River 1 Well 5S Flowline at Igiriukwu. Picture was taken during Joint Investigation of 4th Aug 2017.
