JOINT INVESTIGATION REPORT

INCIDENT NO: 1911557 JIV report S/N: NO: 0000324

1. Spill incident Number: 1911557 2. Type of incident* OIL SPILL
3. Name of Location 20" OTUMARA - ESCRAVOS PIPELINE
4. Name of nearest community UGBOEGUNGUN 5. State: DELTA 6. LGA WARRI SOUTH-WEST
7. Type of Production facility/Installation OIL PIPELINE
8. Asset owner/District THE SHELL PETROLEUM DEVELOPMENT COMPANY OF NIGERIA LIMITED / PIPELINES

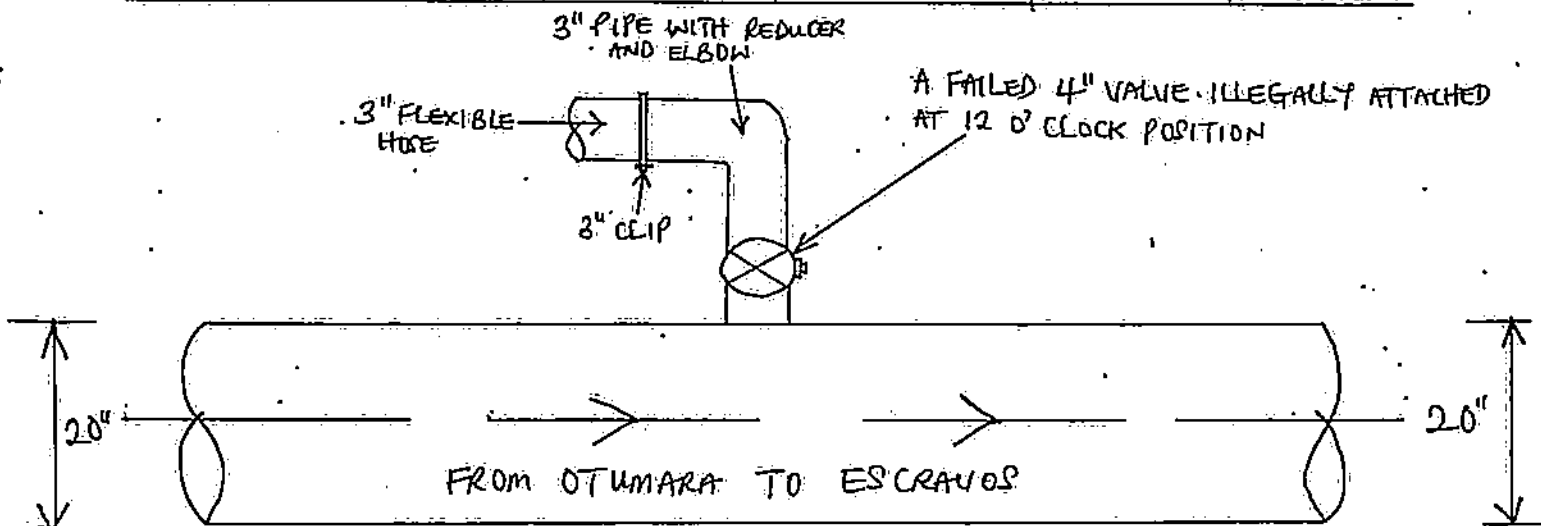
ON EXCAVATION, THE JOINT INVESTIGATION TEAM OBSERVED A FAILED 4" VALVE ILLEGALLY ATTACHED TO THE 20" OTUMARA-ESCRAVOS PIPELINE AT 12 O' CLOCK POSITION. THE LEAK HAS STOPPED AS AT THE TIME OF THIS INVESTIGATION.

SECTION OF 20" OTUMARA-ESCRAVOS PIPELINE AT URBDEGUNGUW AXIS
SHOWING: A FAILED 4" VALVE ILLEGALLY ATTACHED AT 12 O' CLOCK POSITION
