JOINT INVESTIGATION REPORT

INCIDENT NO: 1918070

1. Spill incident Number: 1918070 2. Type of incident* OIL SPILL
3. Name of Location 20" KOLOCREEK - RUMUEKPE PIPELINE
4. Name of nearest community ODAU 5. State: RIVERS 6. LGA ABUA/ODUA
7. Type of Production facility/Installation OIL PIPELINE
8. Asset owner/District THE SHELL PETROLEUM DEVELOPMENT COMPANY OF NIGERIA LIMITED

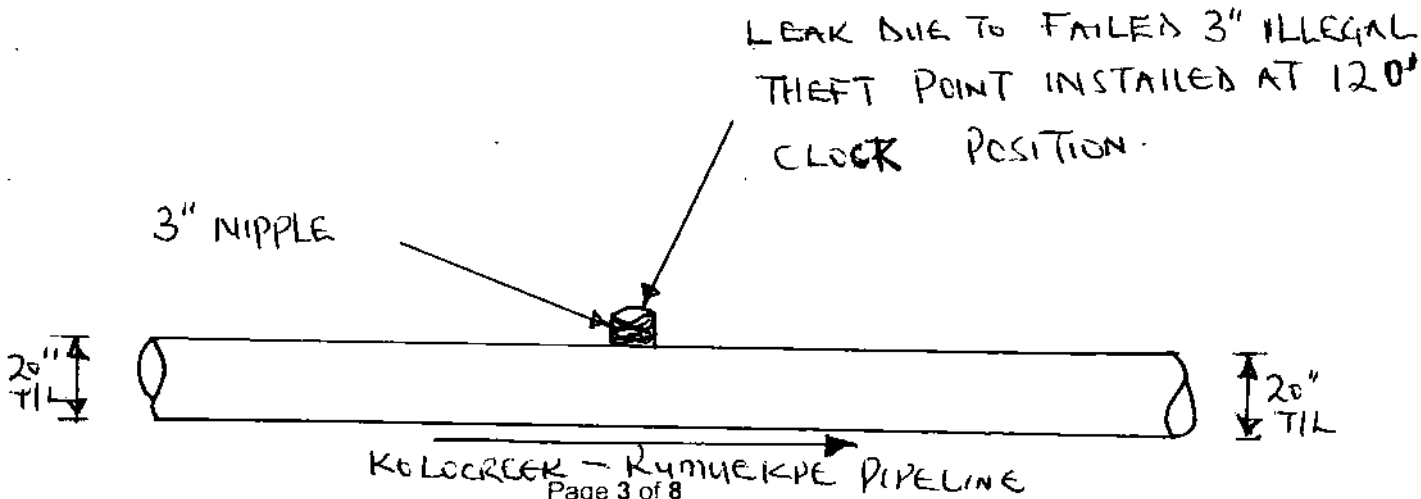
Additional observations around the spill point: CRUDE OIL LEAK FROM AN EARLIER REPORTED NON-LEAKING ILLEGAL CONNECTION, WITH (FID NO 1752257) ON THE 20" KOLO-CREEK - RUMUEKPE PIPELINE AT ODAU, WAC DUE TO FAILED WELD-ON ILLEGAL HOT TAP VALVE AS OBSERVED BY THE JOINT INVESTIGATION TEAM.

SECTIONAL VIEW OF 20" KOLOCREEK - RUMUEKPE PIPELINE AT ODAU SHOWING A FAILED 3" WEID-ON ILLEGAL HOT TAP VALVE.

REPAIR WORK BY CLAMPING AND OIL SPILL RECOVERY
WORK ENGOING.
