# JOINT INVESTIGATION REPORT

INCIDENT NO: 1990258 JIV report S/N: 0977

1. Spill incident Number: 1990258 2. Type of incident\* OIL SPILL  
3. Name of Location 20" RUMUEKPE - NKPOKU TRANS NIGER PIPELINE  
4. Name of nearest community IBAA 5. State: RIVERS 6. LGA EMOTUA  
7. Type of Production facility/Installation OIL PIPELINE  
8. Asset owner/District THE STEEL PETROLEUM DEVELOPMENT COMPANY OF NIGERIA LIMITED

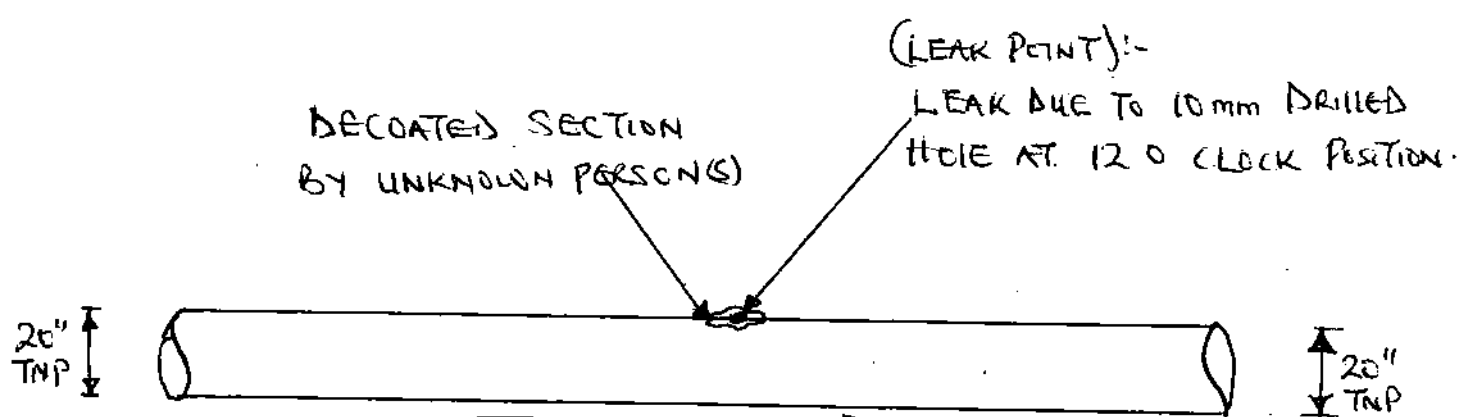
| <input checked="" type="checkbox"/> Drilled hole | <input type="checkbox"/> Jack saw cut | <input type="checkbox"/> Tear (_____), |

**20" RUMUEKPE - NKPOKU TRANS NIGER PIPELINE AT IBAA, SHOWING LEAK DUE TO 10mm DRILLED HOLE AT 12 O'CLOCK POSITION.**

REPAIR WORK BY CLAMPING COMPLETED.
