JOINT INVESTIGATION REPORT

INCIDENT NO: 1986368 JIV report S/N: 0954

1. Spill incident Number: 1986368 2. Type of incident* OIL SPILL/FIRE
3. Name of Location 20" Rumuekpe - Nkpoku Trans Niger Pipeline
4. Name of nearest community IBAA 5. State: RIVERS 6. LGA EMOTUA
7. Type of Production facility/Installation OIL PIPELINE
8. Asset owner/District THE SHELL PETROLEUM DEVELOPMENT COMPANY OF NIGERIA LTD

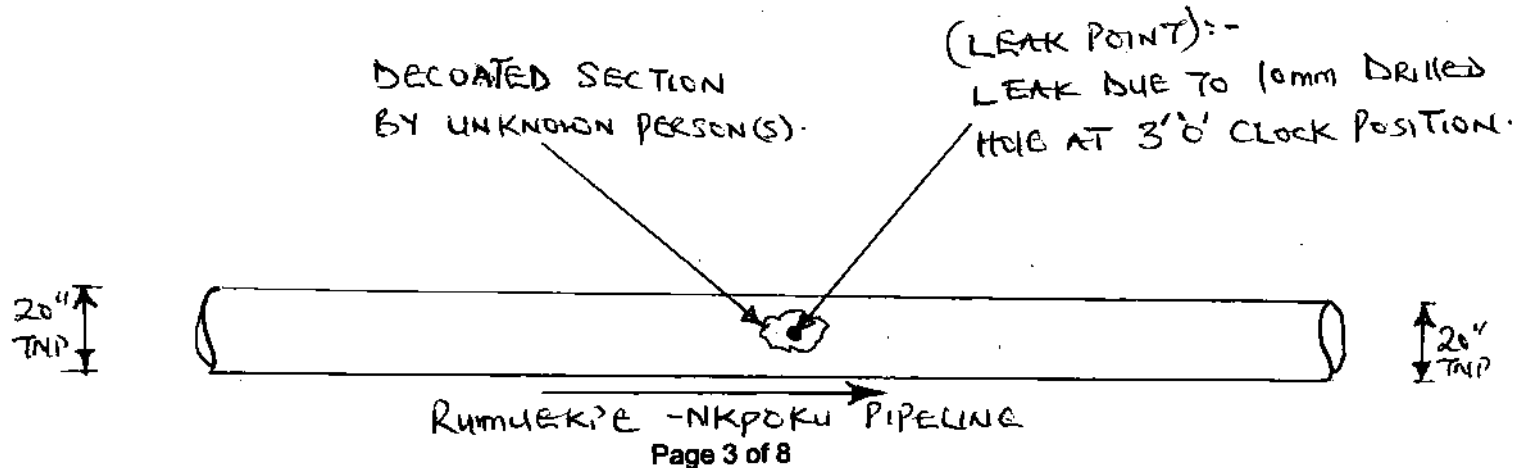
| <input checked="" type="checkbox"/> Drilled hole | <input type="checkbox"/> Hack saw cut | <input type="checkbox"/> Tear (_____) |

E. GRAPHIC DESCRIPTION OF LEAK POINT (While detail report of the leak point should be contained in the leak report, overview sketch of the site should be added as an appendix I) :- **SECTIONAL VIEW OF 20" Rumuŋkpe - Nkpoku TRANS NIGERI PIPELINE AT IBAA, SHOWING:- LEAK DUE TO 10mm DRILLED HOLE AT 3'O' CLOCK POSITION.**

REPAIR WORK BY CLAMPING COMPLETED

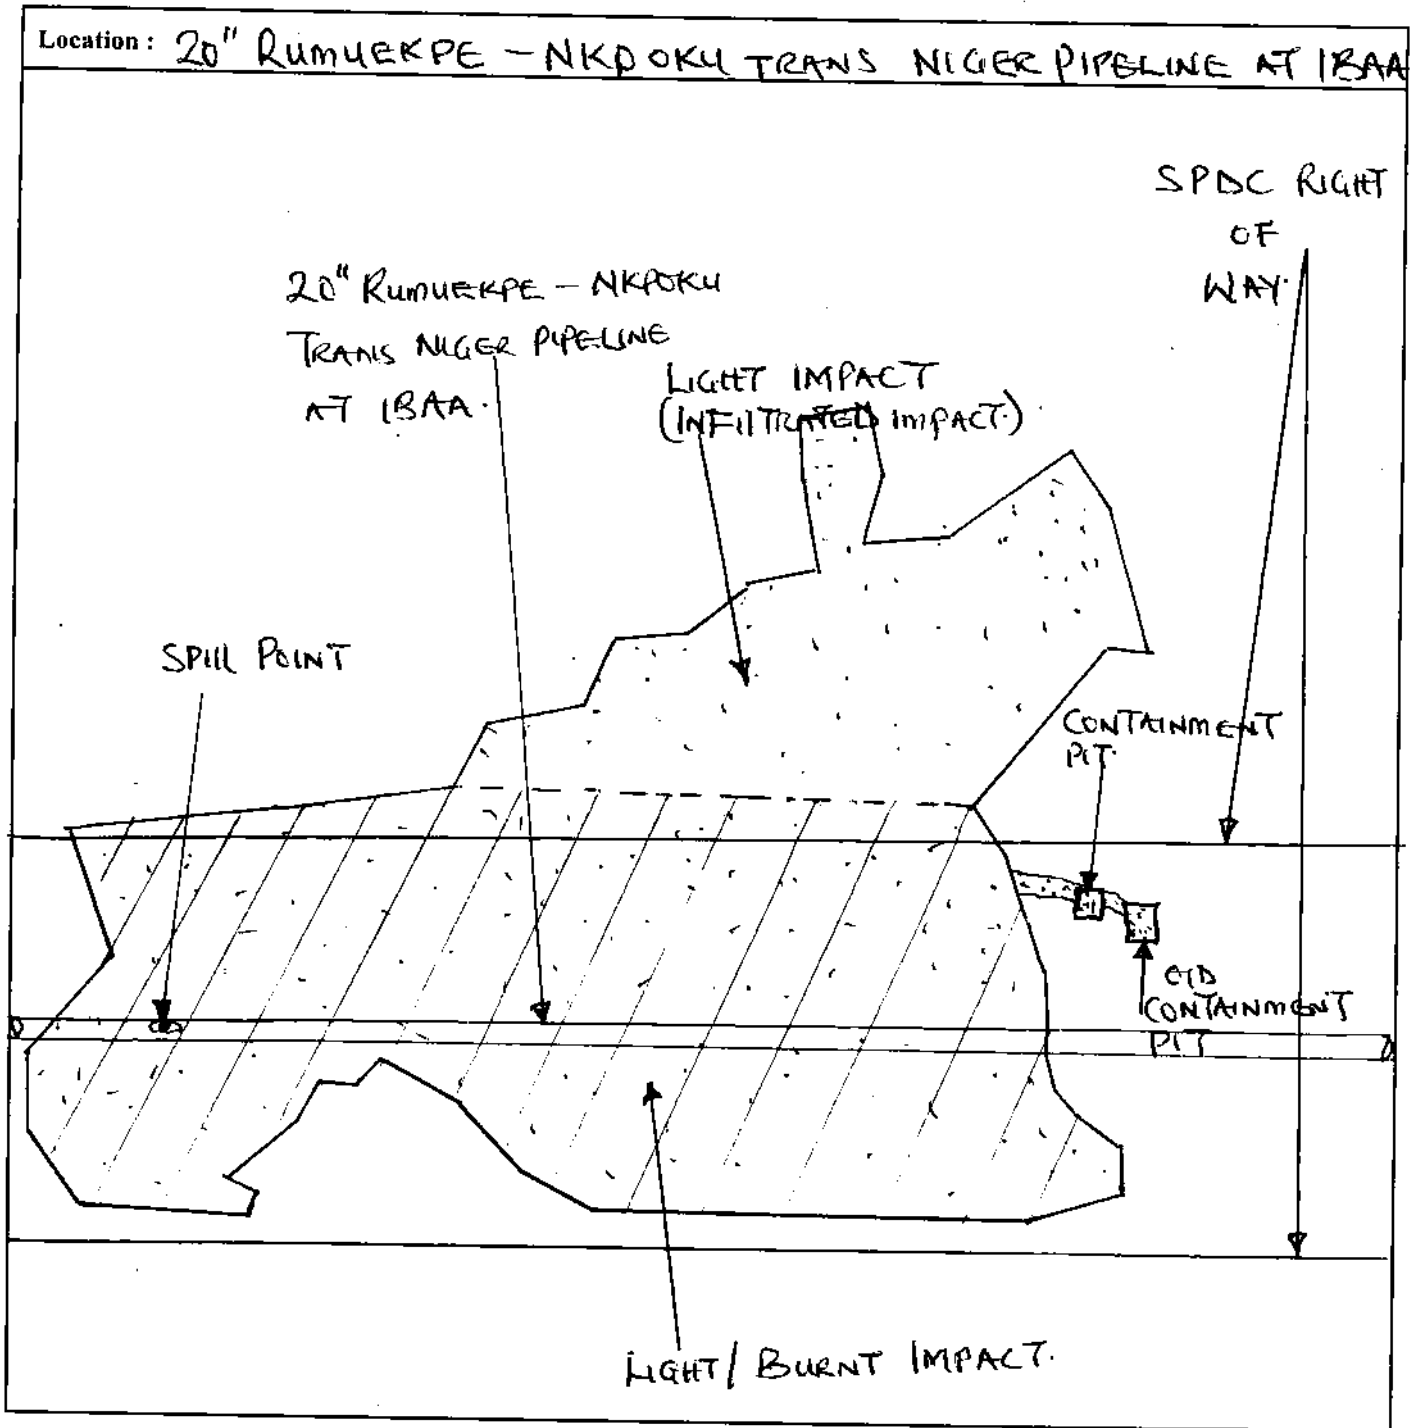
f. Appendix 1: Overview sketch of the site

- Total calculated area of impact 0.40HA
- Impact within R.O.W YES
- Impact outside R.O.W YES
