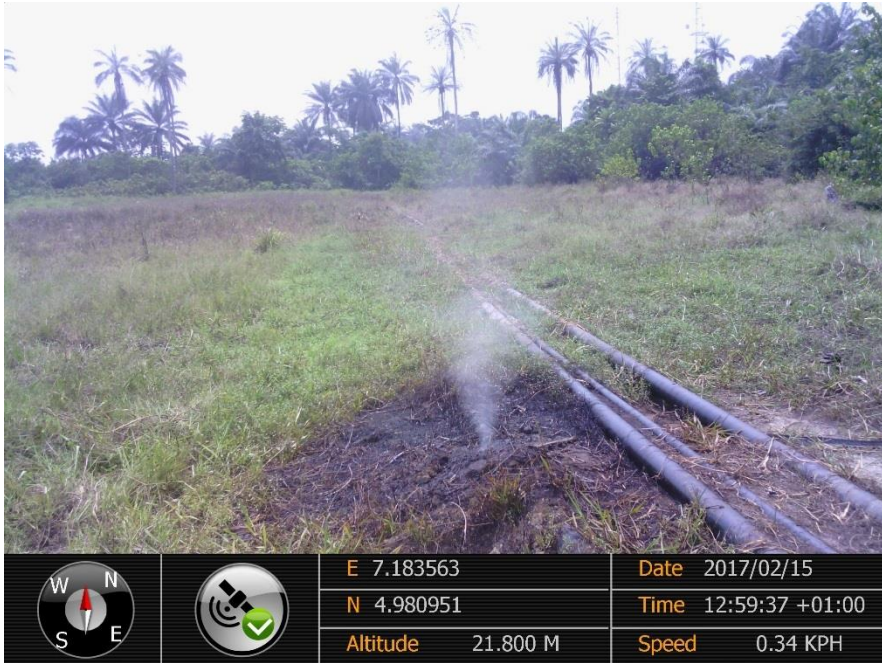
**Overview:** Part of spill impact on Imo River 1 Well 36 Flowline IgiriUkwu-Owaza. Picture was taken during Joint Investigation of 15<sup>th</sup> February 2017.

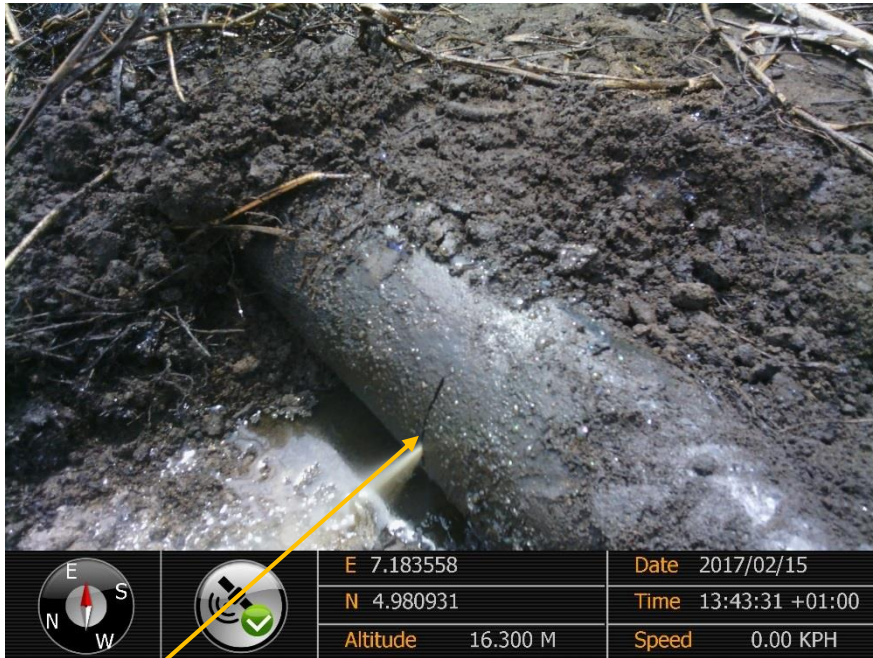
**Close-up:** Hacksaw cut on Imo River 1 Well 36 Flowline IgiriUkwu-Owaza. Picture was taken during Joint Investigation of 15<sup>th</sup> February 2017.
