JOINT INVESTIGATION REPORT

INCIDENT NO: 1803899 JIV report S/N: N° 0000240

1. Spill incident Number: 1803899 2. Type of incident* OIL SPILL
3. Name of Location 12" IMO RIVER 2 - OGAGE (TRUNKLINE) PIPELINE
4. Name of nearest community ODAGWA 5. State: RIVERS 6. LGA ABUA / ODUAL
7. Type of Production facility/Installation OIL PIPELINE
8. Asset owner/District THE SHELL PETROLEUM DEVELOPMENT COMPANY OF NIGERIA LIMITED

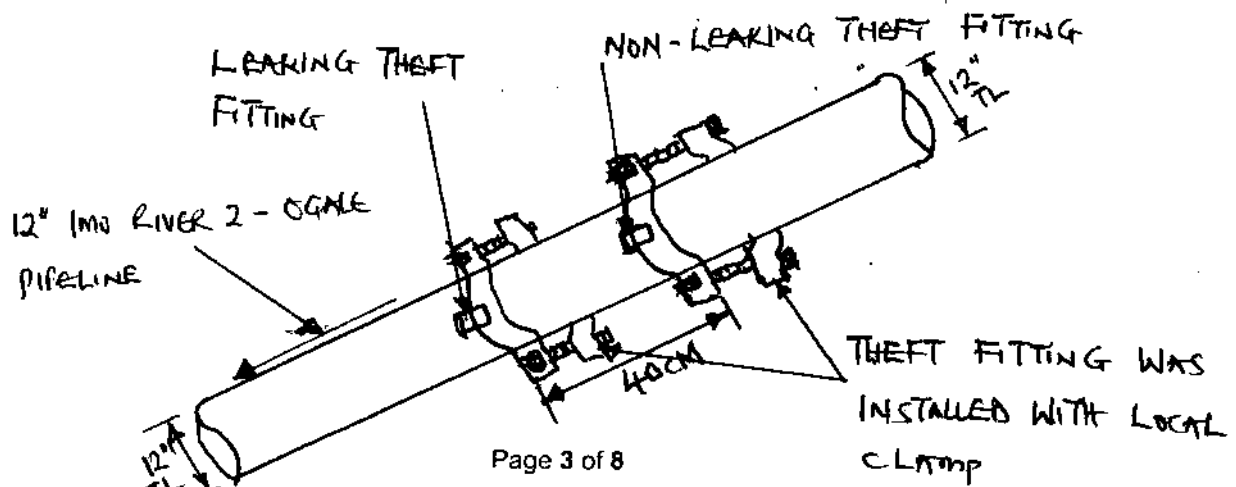
Additional observations around the spill point: THE JOINT INVESTIGATION TEAM OBSERVED TWO NUMBER ILLEGAL (THEFT) FITTINGS WITH LOCALLY FABRICATED CLAMPS INSTALLED BY UNKNOWN PERSON(S)

| <input checked="" type="checkbox"/> Failed (Weld-on) illegal hot tap valve | <input type="checkbox"/> Failed Clamp, | <input type="checkbox"/> Missing Pipeline/Flowline |
| <input checked="" type="checkbox"/> Crude oil theft (illegal bunkering) point, | <input type="checkbox"/> Saver-pit over flow | <input type="checkbox"/> Third party tampering with Clamp |

SECTIONAL VIEW OF 12" IMO RIVER 2 - OGALÉ (TRUNKLINE) PIPELINE AT ODAGWA SHOWING TWO (2) INSTALLED THEFT FITTING AT 12'-0 O'CLOCK POSITION WITH LOCALLY CONSTRUCTED CLAMP.

CRUDE OIL RECOVERY AND PIPELINE REPAIR BY CLAMPING ARE ONGOING.
