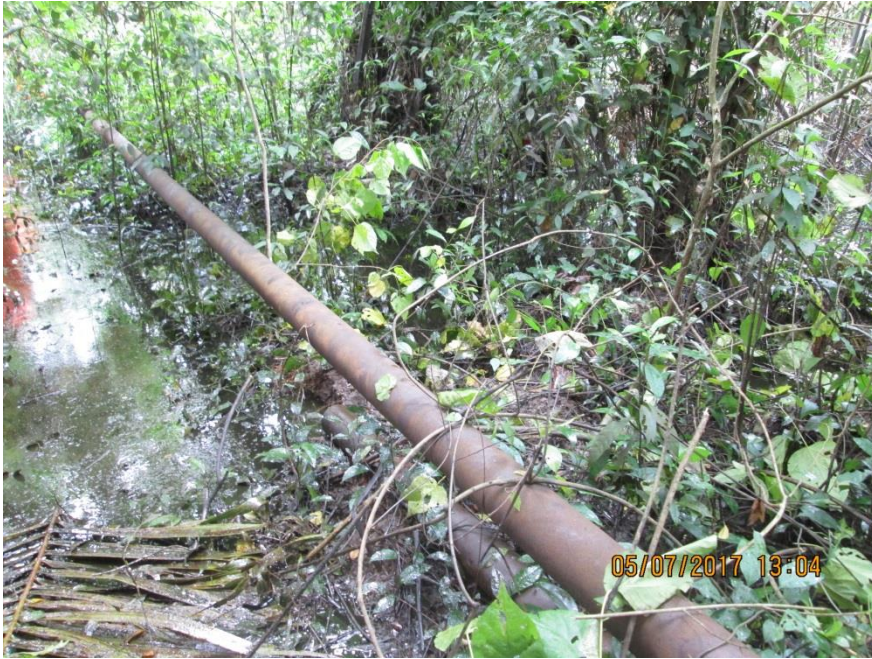
Overview: Part of spill impact on 4" Adibawa Well 2S Flowline Right of Way at Edagberi-Betterland. Picture was taken during Joint Investigation of 5<sup>th</sup> July 2017.

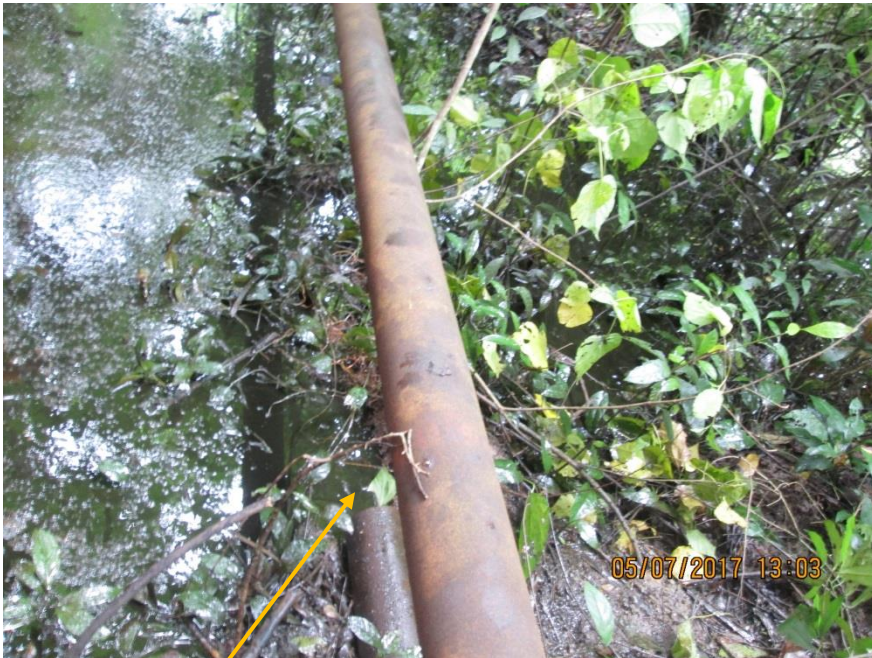
Close-up: Section of Missing Flowline on 4" Adibawa Well 2S Flowline at Edagberi-Betterland. Picture was taken during Joint Investigation of 5<sup>th</sup> July 2017.

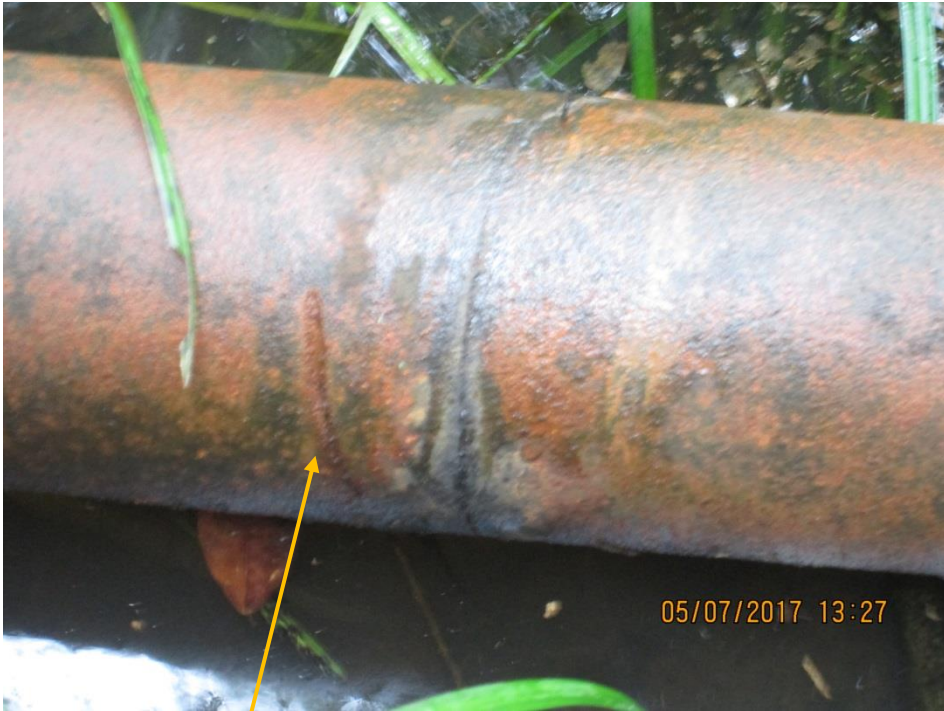
Close-up: Hacksaw Cut on 4" Adibawa Well 2L Flowline at Edagberi-Betterland. Picture was taken during Joint Investigation of 5<sup>th</sup> July 2017.
