JOINT INVESTIGATION REPORT

INCIDENT NO: 1896813 JIV report S/N: Nº 5000400

1. Spill incident Number: 1896813 2. Type of incident* OIL SPILL
3. Name of Location 4" TUNU. WELL - 4L FLOWLINE
4. Name of nearest community AGBIDIAMA 5. State: BAYELSA 6. LGA EKEREMOR
7. Type of Production facility/Installation FLOWLINE
8. Asset owner/District THE SHELL PETROLEUM DEVELOPMENT COMPANY OF NIGERIA LIMITED / SWAMP WEST

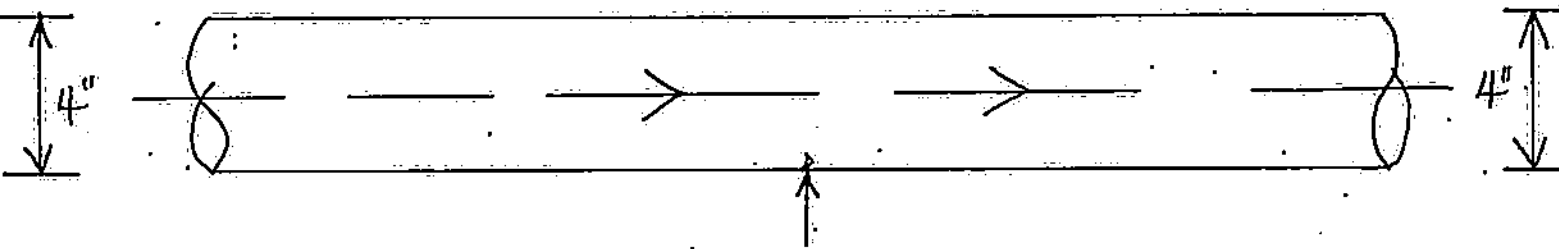
Additional observations around the spill point: ON LIFTING THE FLOWLINE, THE JOINT INVESTIGATION TEAM OBSERVED A CORRODED LEAK POINT (ABOUT 4CM LONG) AT THE HEAT AFFECTED ZONE, NEAR A WELDED JOINT AT 6 O' CLOCK POSITION. THE LEAK WAS OBSERVED TO HAVE STOPPED AS AT THE TIME OF THIS INVESTIGATION.

E. GRAPHIC DESCRIPTION OF LEAK POINT (while detail report of the leak point should be contained in the leak report, overview sketch of the site should be added as an appendix 1)
 SECTION OF 4" TUNU WELL-4L FLOWLINE AT AEBDIAMA, SHOWING POSITION OF CORRODED LEAK POINT (ABOUT 4CM LONG) AT 6 O' CLOCK.

CORRODED LEAK POINT (ABOUT 4CM LONG)
AT 6 O' CLOCK POSITION
