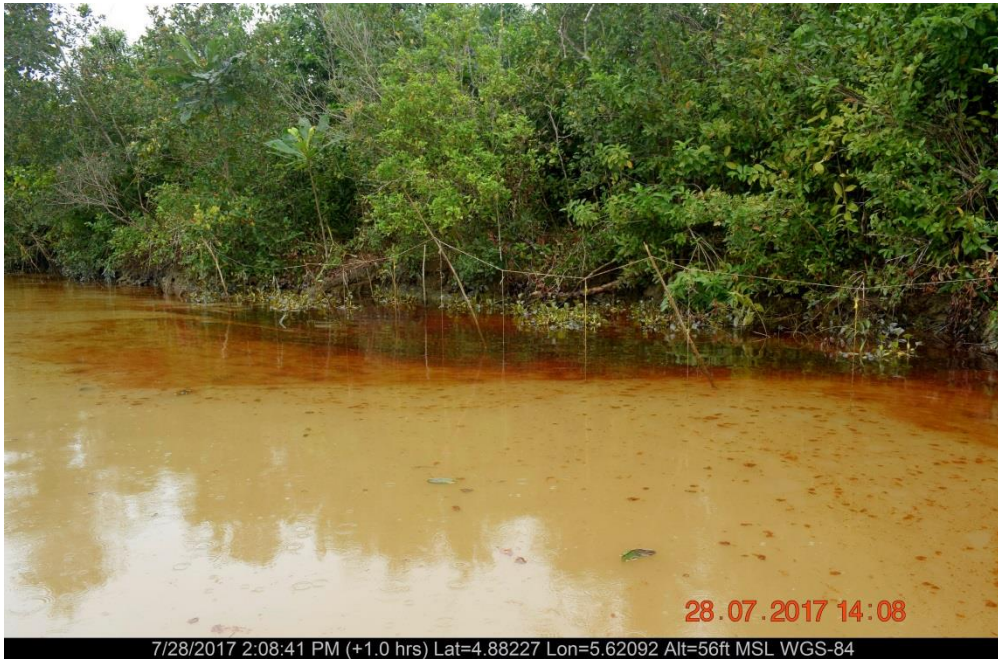
Overview: Part of spill impact on 4" Tunu Well-4L Flowline at Agbidiana. Picture was taken during Joint Investigation of 28<sup>th</sup> July 2017.

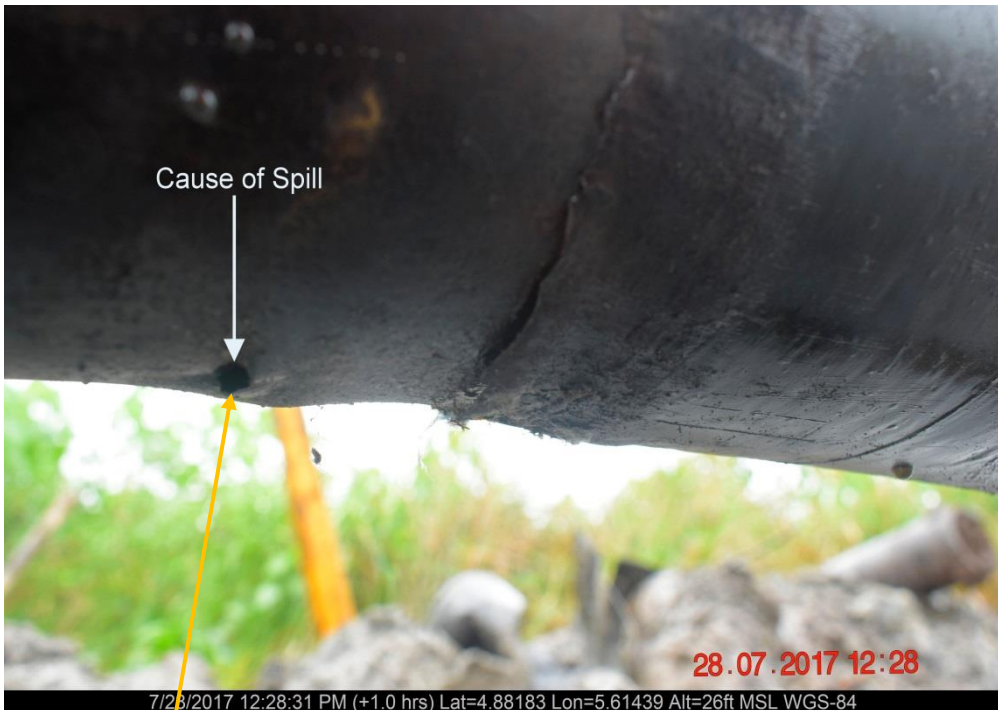
Close-up: Corrosion on 4" Tunu Well-4L Flowline at Agbidiana. Picture was taken during Joint Investigation of 28<sup>th</sup> July 2017.
