# JOINT INVESTIGATION REPORT

INCIDENT NO: 188 97 04 JIV report S/N: No. 0000323

1. Spill incident Number: 188 97 04 2. Type of incident\* OIL SPILL  
3. Name of Location 20" OTUMARA - ESCRAVOS PIPELINE  
4. Name of nearest community UGBOEGUNGUN State: DELTA 6. LGA WARRI SOUTH-WEST  
7. Type of Production facility/Installation OIL PIPELINE  
8. Asset owner/District THE SHELL PETROLEUM DEVELOPMENT COMPANY OF

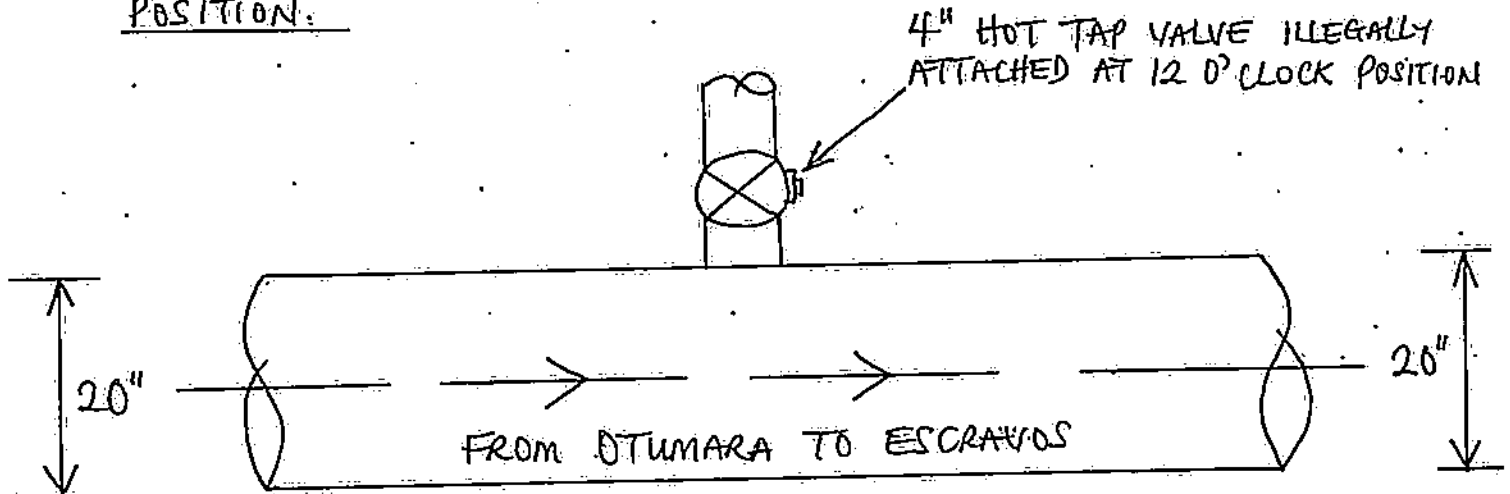
ON EXCAVATION, THE JOINT INVESTIGATION TEAM OBSERVED A 4" VALVE ILLEGALLY ATTACHED TO THE 20" OTUMARA - ESCRAVOS PIPELINE AT 12 O' CLOCK POSITION.

| <input checked="" type="checkbox"/> Failed Weld-on illegal hot tap valve | <input type="checkbox"/> Failed Clamp, | <input type="checkbox"/> Missing Pipeline/Flowline |
| <input checked="" type="checkbox"/> Crude oil theft (illegal bunkering) point, | <input type="checkbox"/> Saver-pit over flow | <input type="checkbox"/> Third party tampering with Clamp |

SECTION OF 20" OTUMARA - ESCRAVOS PIPELINE AT UGBOEGUNGUN  
SHOWING: A 4" HOT TAP VALVE ILLEGALLY ATTACHED AT 12 O' CLOCK  
POSITION:

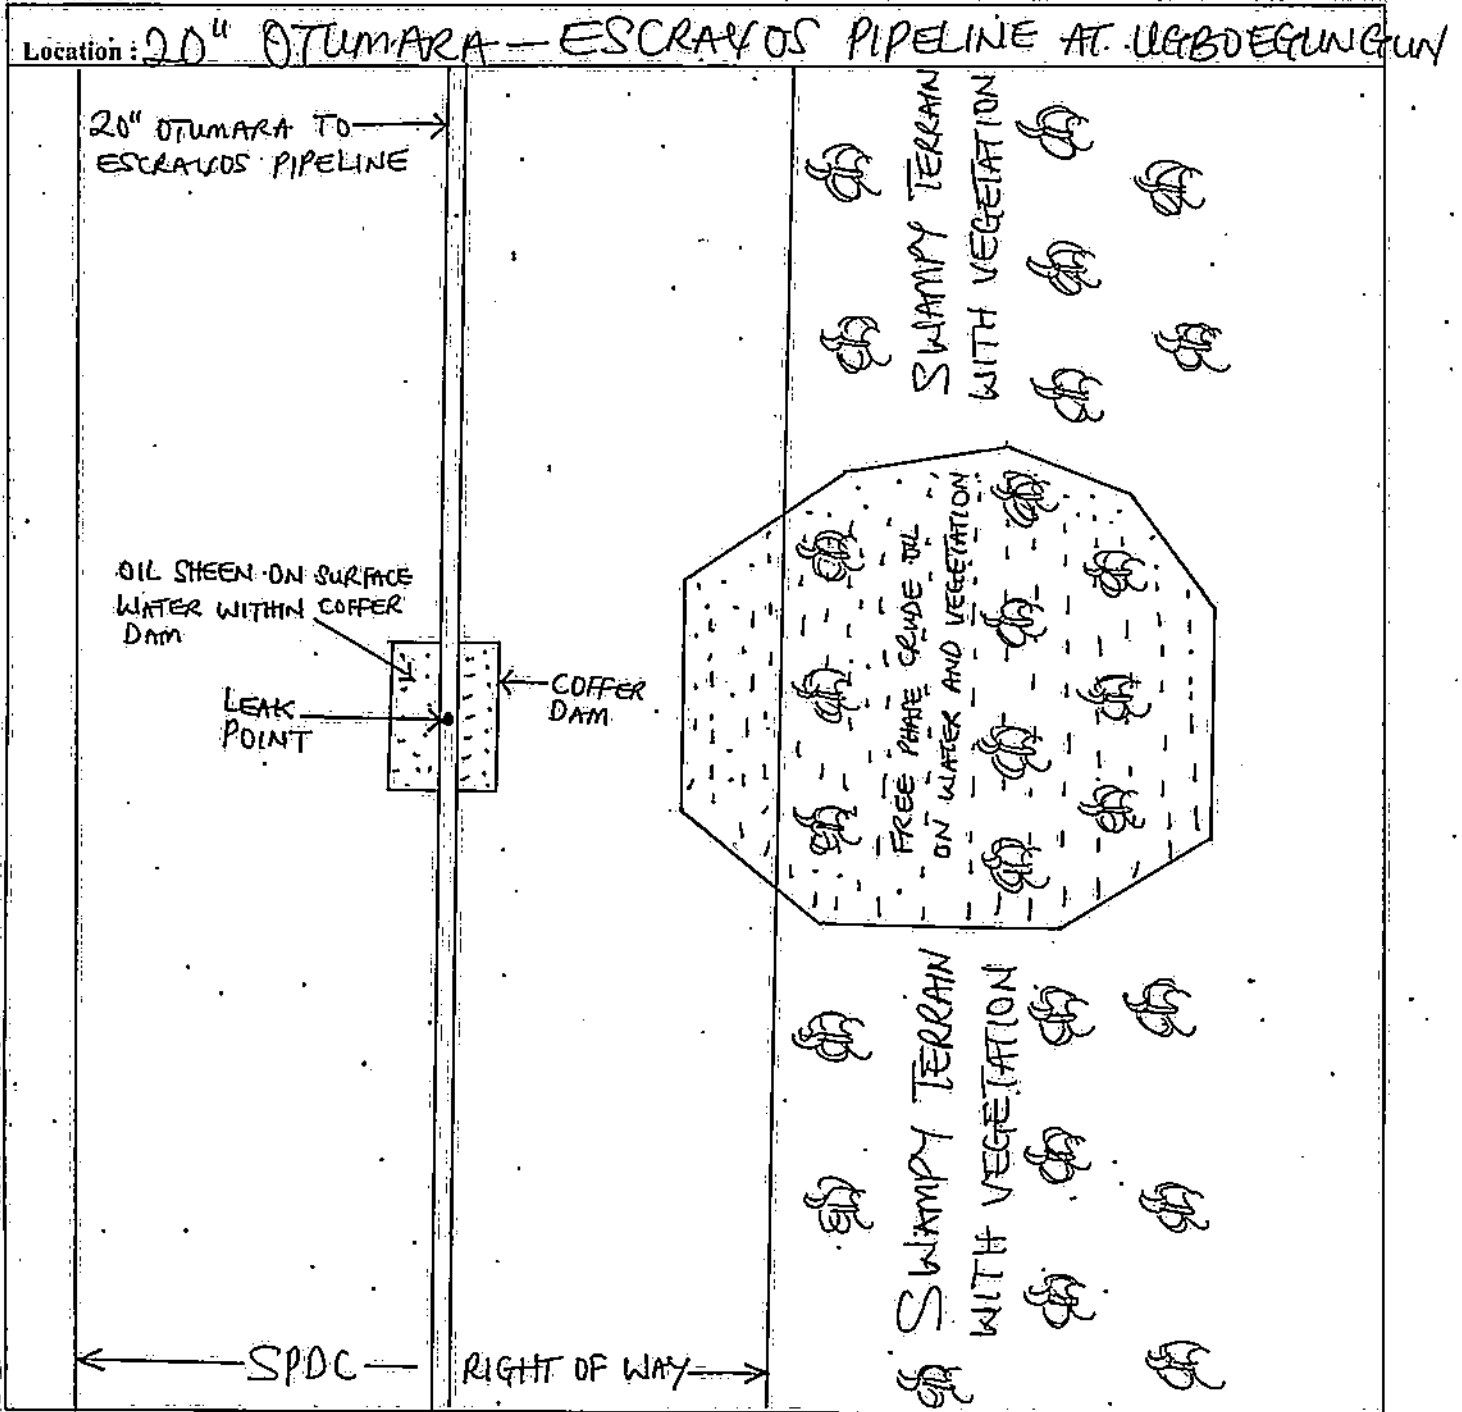
f. Appendix I: Overview sketch of the site

- Total calculated area of impact 0.8302 HA
- Impact within R.O.W YES
- Impact outside R.O.W YES
