# JOINT INVESTIGATION REPORT

INCIDENT NO: 1899560 JIV report S/N: Nº 0000329

1. Spill incident Number: 1899560 2. Type of incident\* OIL SPILL  
3. Name of Location BELEMA FLOW STATION  
4. Name of nearest community BELEMA 5. State: RIVERS 6. LGA AKUKU-TORU  
7. Type of Production facility/Installation FLOW STATION  
8. Asset owner/District THE SHELL PETROLEUM DEVELOPMENT COMPANY OF NIGERIA LIMITED / SWAMP EAST HUB

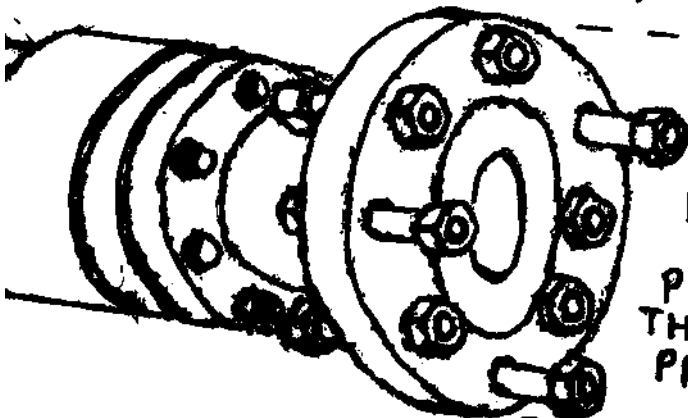
BLIND-FLANGE  
INSTALLED BY THE  
ASSET OWNER (AS  
A WAY OF POSITIVE  
ISOLATION) PRIOR  
TO THE J.I.V.

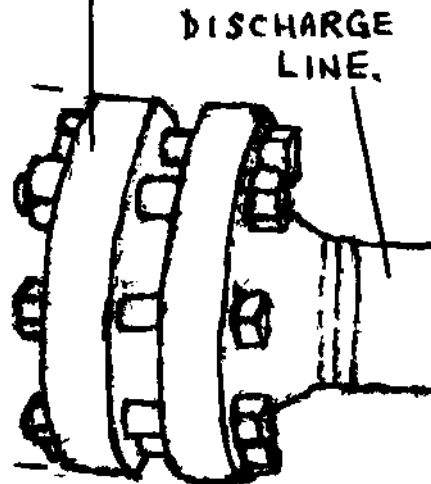
Additional observations around the spill point: **THE SPILL POINT (A RUPTURED FLEXIBLE DISCHARGE SPOOL PIECE), WHICH WAS REMOVED FROM ITS ORIGINAL POSITION BY THE ASSET OWNER PRIOR TO THE J.I.V. TO ENABLE POSITIVE ISOLATION BY BLIND-FLANGING, WAS SHOWN TO THE INVESTIGATION TEAM OFF-SITE. PICTURES TAKEN OF THE SPILL POINT (IN POSITION) BY THE ASSET OWNER WERE ALSO SHOWN. AT SITE, OIL STAINS WERE NOTICED ON THE ROOF AND THE SECONDARY CONTAINMENT UNDER THE GRATING FLOOR OF THE FLOW STATION.**

ORIGINAL POSITION  
OF RUPTURED  
FLEXIBLE DISCHARGE  
SPOOL PIECE (LEAK  
POINT) REMOVED BY  
THE ASSET OWNER  
PRIOR TO J.I.V.
