JOINT INVESTIGATION REPORT

INCIDENT NO: 1824061

1. Spill incident Number: 1824061 2. Type of incident* OIL SPILL
3. Name of Location 4" OBELE - IBAA (DELIVERY LINE) PIPELINE
4. Name of nearest community IBAA 5. State: RIVERS 6. LGA EMOHUA
7. Type of Production facility/Installation OIL PIPELINE
8. Asset owner/District THE SHELL PETROLEUM DEVELOPMENT COMPANY OF NIGERIA LIMITED.

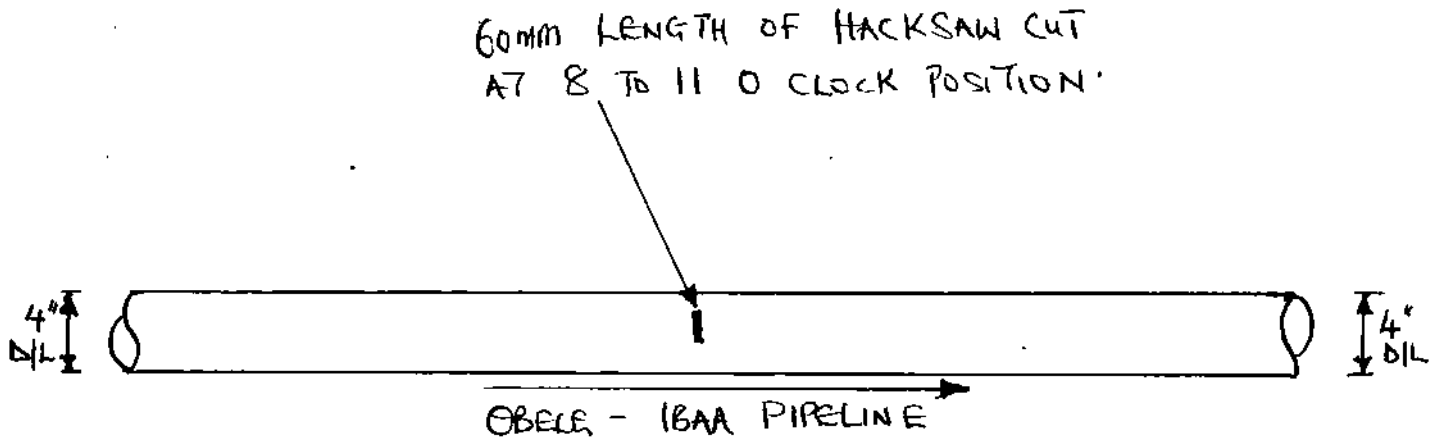
| <input type="checkbox"/> Drilled hole | <input checked="" type="checkbox"/> Hack saw cut | <input type="checkbox"/> Tear (_____), |

- Third party interference (Sabotage ; crude theft ; Line theft ; Accidental 3rd party damage
 Operational Others (including Mystery spills) _____

SECTIONAL VIEW OF 4" OBELE - IBAA (DELIVERY LINE) PIPELINE AT IBAA
SHOWING (MULTIPLE) HACKSAW CUT ON THE DELIVERY LINE.

REPAIR WORK ONGOING
