JOINT INVESTIGATION REPORT

INCIDENT NO: 1963638 JIV report S/N: 0910

1. Spill incident Number: 1963638 2. Type of incident* OIL SPILL
3. Name of Location NUN RIVER WELL 15 WELL HEAD
4. Name of nearest community ONYOMA 5. State: BAYELSA 6. LGA SOUTHERN IJAW
7. Type of Production facility/Installation WELL HEAD
8. Asset owner/District THE SHELL PETROLEUM DEVELOPMENT COMPANY OF NIGERIA LIMITED / CENTRAL HUB

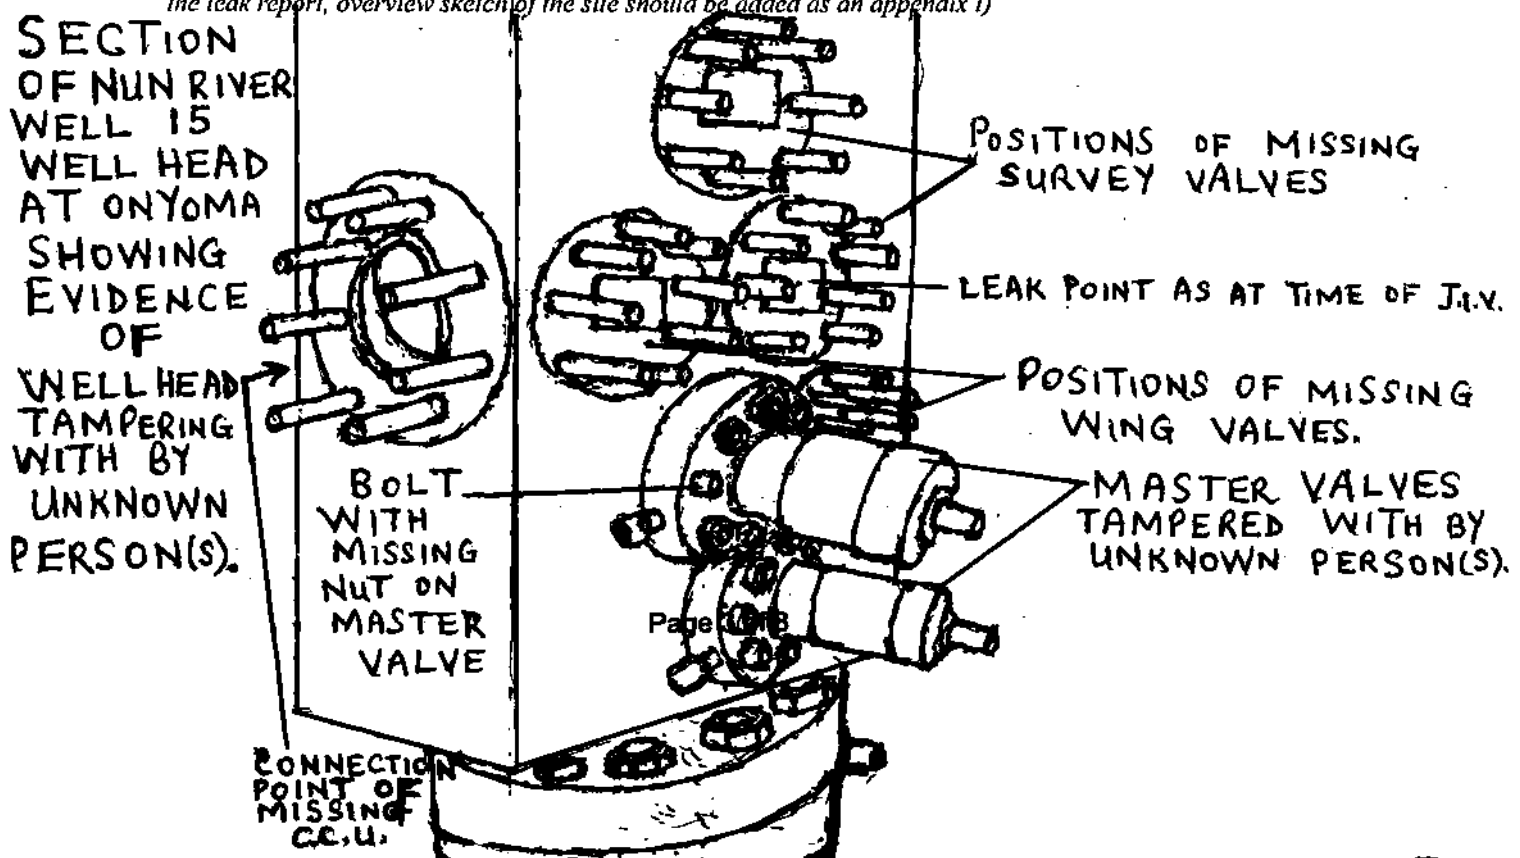
E. GRAPHIC DESCRIPTION OF LEAK POINT *(While detail report of the leak point should be contained in the leak report, overview sketch of the site should be added as an appendix I)*

Additional observations around the spill point: **ON ARRIVAL AT SITE, THE SURVEY VALVES, WING VALVES, ANNULUS B VALVES AND CAMERON CONTROL UNITS (C.C.U) WERE ALL NOTICED TO HAVE BEEN REMOVED BY UNKNOWN PERSON(S) WHO ALSO TAMPERED WITH THE MASTER VALVES. LEAK WAS OBSERVED FROM ONE OF THE MISSING SURVEY VALVE POSITIONS. OIL STAINS WERE NOTICED ON THE METAL GRATING (ON WHICH SOME BOLTS AND O-RINGS REMOVED BY UNKNOWN PERSON(S) WERE ALSO FOUND).**
