JOINT INVESTIGATION REPORT

INCIDENT NO: 1974218 JIV report S/N: 0916

1. Spill incident Number: 1974218 2. Type of incident* OIL SPILL
3. Name of Location 20" KOLO CREEK - RUMUEKPE PIPELINE
4. Name of nearest community ODAU 5. State: RIVERS 6. LGA ABUA/ODUAL
7. Type of Production facility/Installation OIL PIPELINE
8. Asset owner/District THE SHELL PETROLEUM DEVELOPMENT COMPANY OF NIGERIA LIMITED / PIPELINE

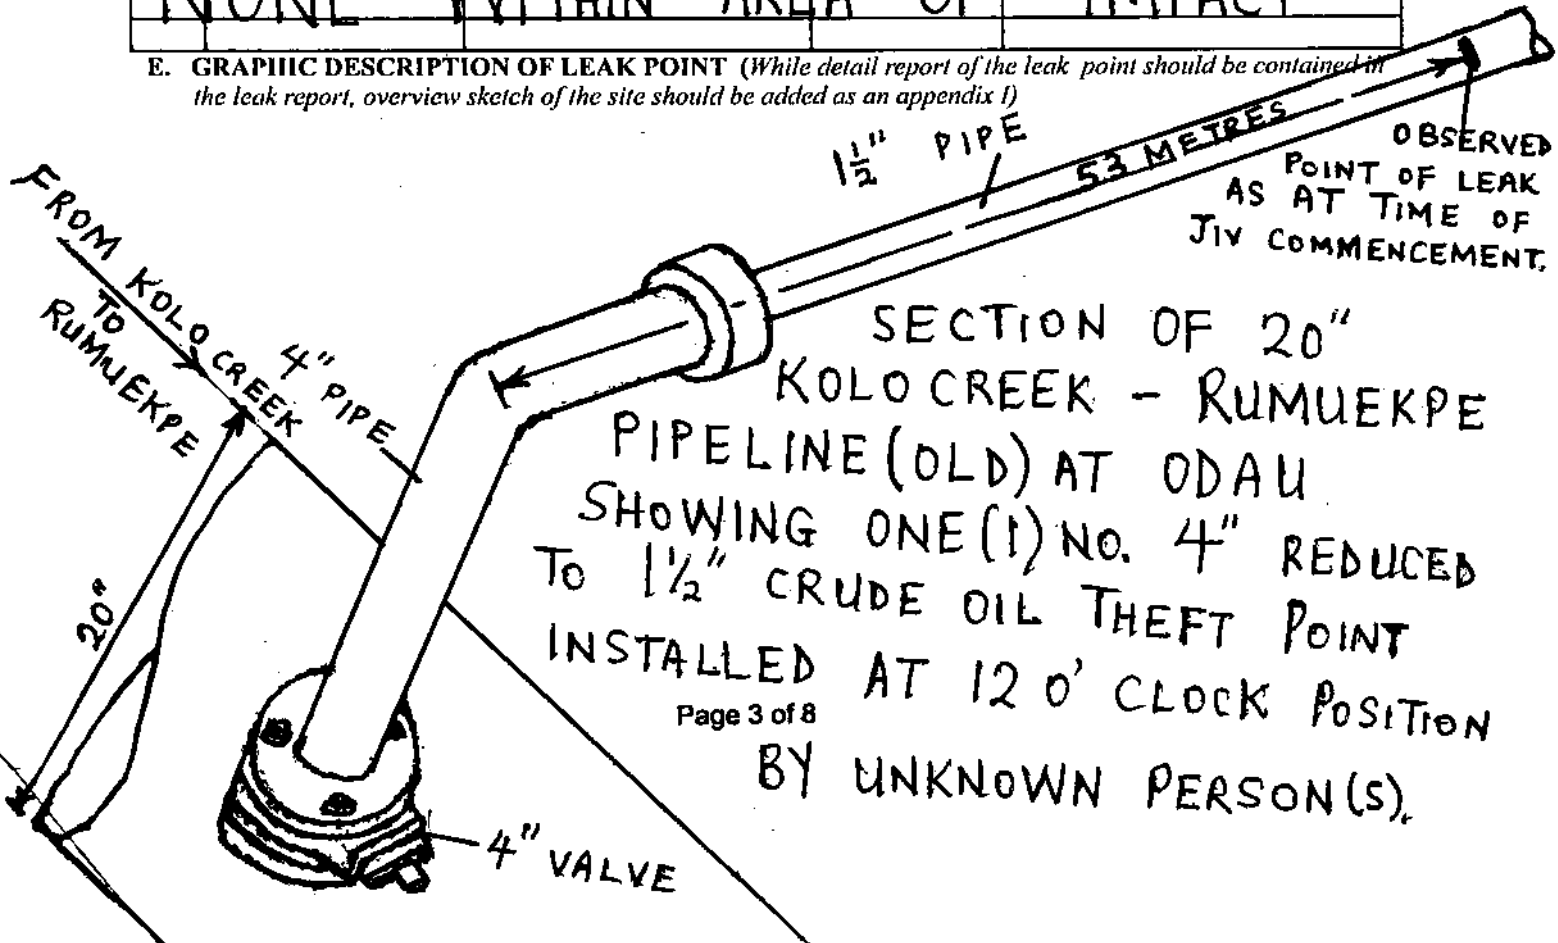
E. GRAPHIC DESCRIPTION OF LEAK POINT *(While detail report of the leak point should be contained in the leak report, overview sketch of the site should be added as an appendix 1)*

Additional observations around the spill point: **AN ILLEGAL PIPE CONNECTION WAS OBSERVED RUNNING FROM THE SPILL POINT INTO THE SURROUNDING FOREST.**

| <input checked="" type="checkbox"/> Crude oil theft (illegal bunkering) point, | <input type="checkbox"/> Saver-pit over flow | <input type="checkbox"/> Third party tampering with Clamp |

REPAIR WAS DONE TEMPORARILY BY BLIND-FLANGING AND
INSTALLING RESTRICTION AT THE CRUDE OIL THEFT POINT.
