JOINT INVESTIGATION REPORT

INCIDENT NO: 1943990 JIV report S/N: 0942

1. Spill incident Number: 1943990 2. Type of incident* OIL SPILL
3. Name of Location 18" ASSA - RUMUOKPE (TRUNKLINE) PIPELINE
4. Name of nearest community AWARA 5. State: IMO 6. LGA OHAJI/EGBEMA
7. Type of Production facility/Installation OIL PIPELINE
8. Asset owner/District THE SHELL PETROLEUM DEVELOPMENT COMPANY OF NIGERIA LIMITED

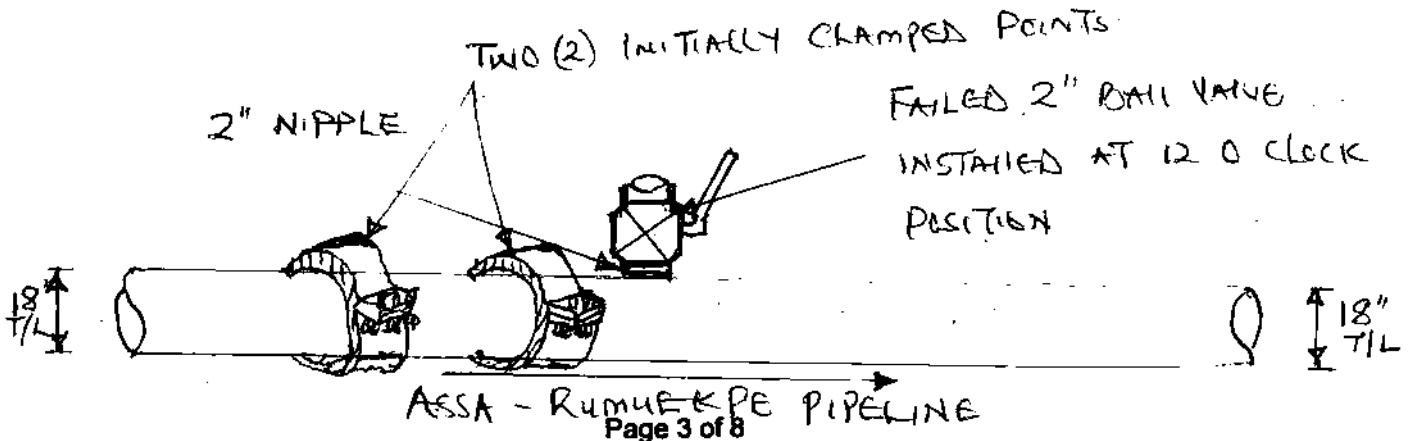
Additional observations around the spill point: THE JOINT INVESTIGATION TEAM SAW SAND BAGS USED TO CONCEAL THE ILLEGAL THEFT POINT POSITION CLOSE TO TWO (2) INITIALLY CLAMPED POINTS.

| <input checked="" type="checkbox"/> Failed Weld-on illegal hot tap valve | <input type="checkbox"/> Failed Clamp, | <input type="checkbox"/> Missing Pipeline/Flowline |
| <input checked="" type="checkbox"/> Crude oil theft (illegal bunkering) point, | <input type="checkbox"/> Saver-pit over flow | <input type="checkbox"/> Third party tampering with Clamp |

SECTIONAL VIEW OF 18" ASSA - RUMUEKPE TRUNKLINE PIPELINE AT AWARA
AWARA SHOWING FAILED 2" ILLEGAL THEFT POINT INSTALLED
AT 12 O'CLOCK POSITION.

REPAIR WORK BY CLAMPING AND OIL SPILL RECOVERY
WORK ONGOING

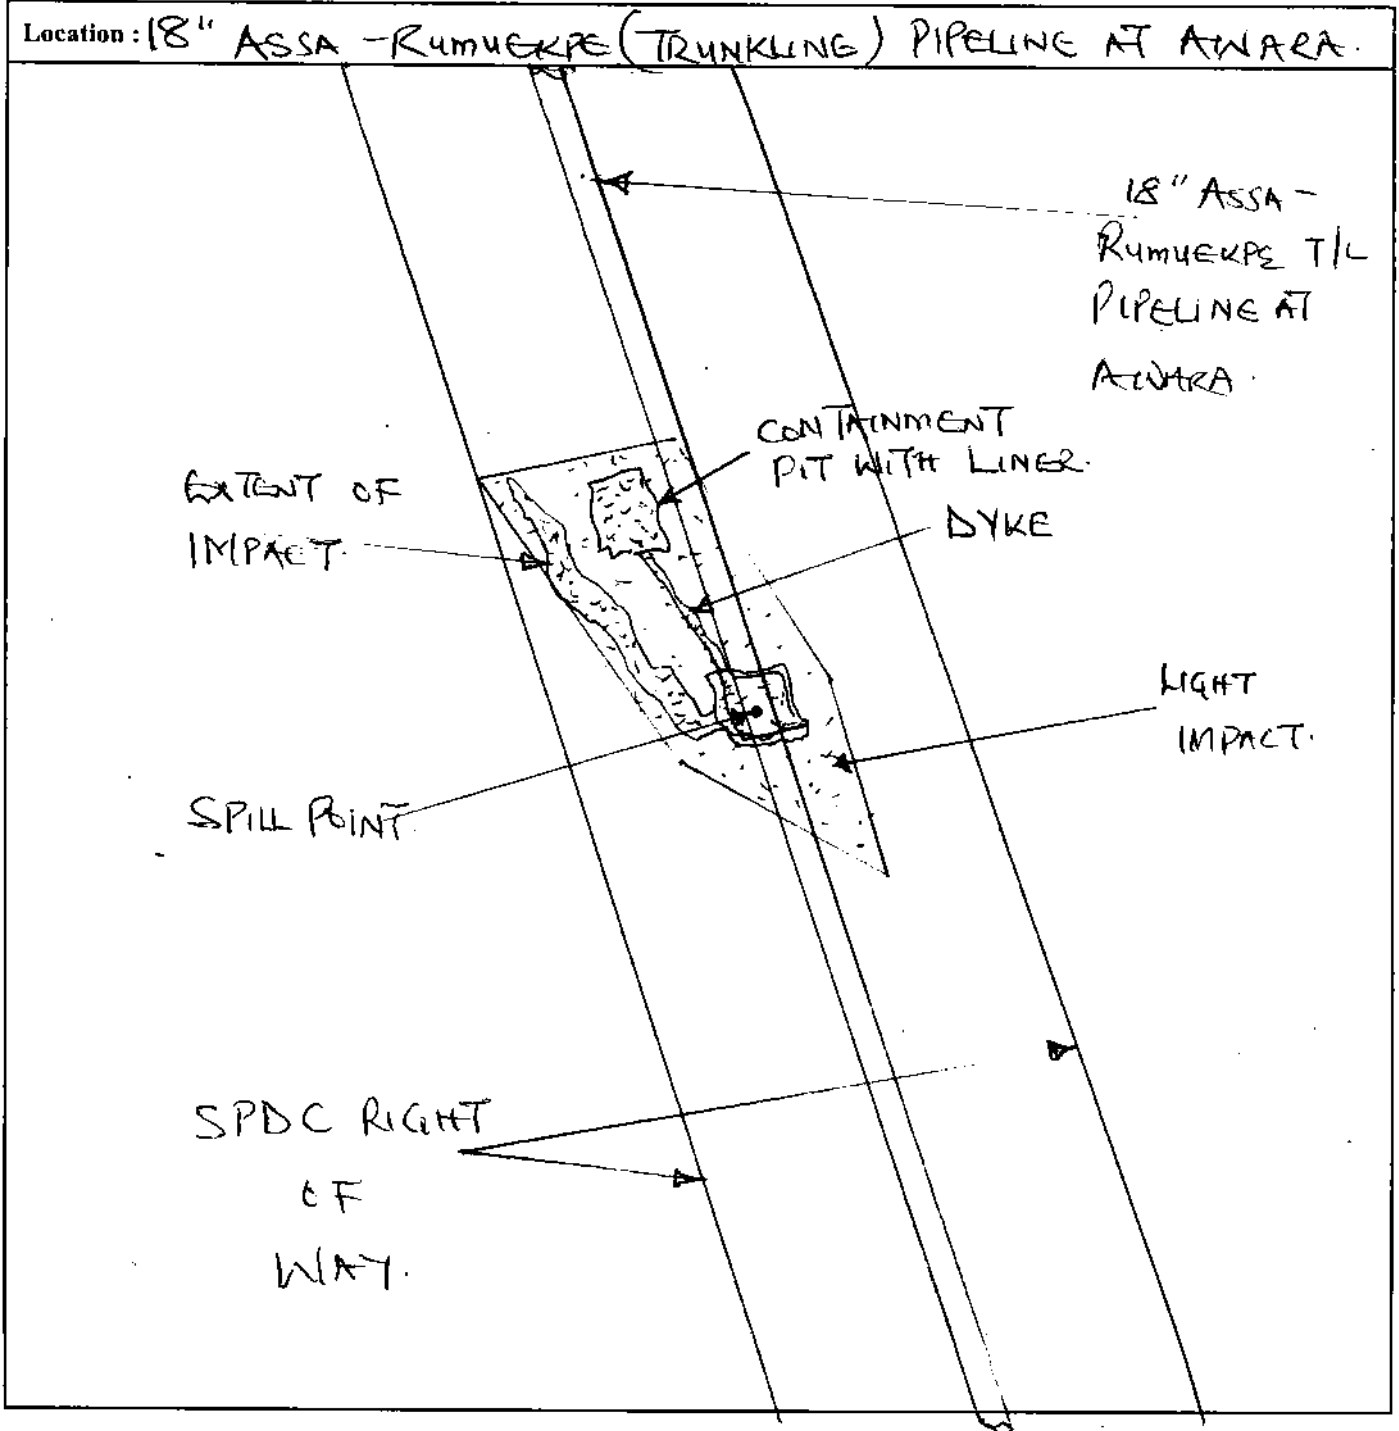
f. Appendix 1: Overview sketch of the site

- Total calculated area of impact 0.0068ha
- Impact within R.O.W YES
- Impact outside R.O.W NO
