JOINT INVESTIGATION REPORT

INCIDENT NO: 1955746 JIV report S/N: 1105

- 1. Spill incident Number: 1955746 2. Type of incident* OIL SPILL
- 3. Name of Location 20" OTUMARA - ESCRAVOS PIPELINE
- 4. Name of nearest community UGBOEGUNGUN, State: DELTA 6. LGA WARRI SOUTH-WEST
- 7. Type of Production facility/Installation OIL PIPELINE
- 8. Asset owner/District THE SHELL PETROLEUM DEVELOPMENT COMPANY OF NIGERIA LIMITED / PIPELINES

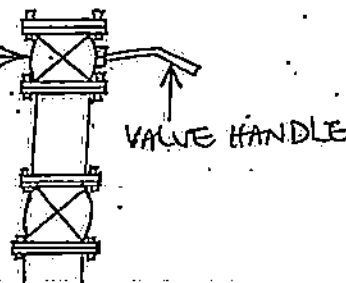
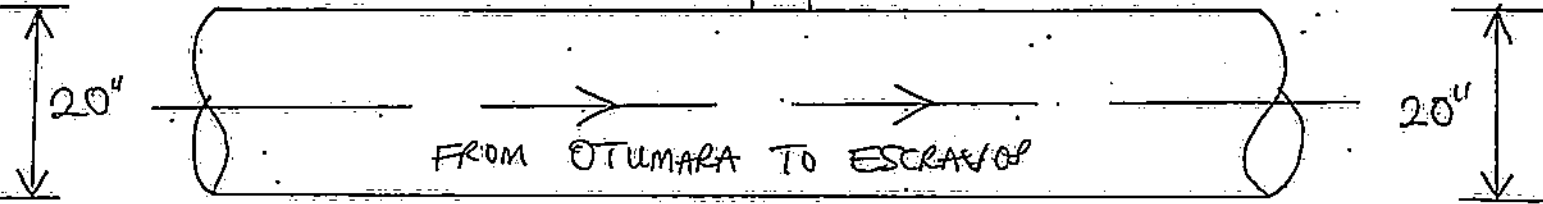
Additional observations around the spill point: ON EXCAVATION, THE JOINT INVESTIGATION TEAM OBSERVED A FAILED 3" VALVE, ILLEGALLY ATTACHED TO THE 20" OTUMARA - ESCRAVOS PIPELINE AT 12 O' CLOCK POSITION.

E. GRAPHIC DESCRIPTION OF LEAK POINT (While detail report of the leak point should be contained in the leak report, overview sketch of the site should be added as an appendix I)
SECTION OF 20" OTUMARA - ESCRAVOP PIPELINE AT UGBOEGUNGUN
SHOWING POSITION OF 3" FAILED VALVE AT 12 O' CLOCK

FAILED 3" VALVE ILLEGALLY ATTACHED AT 12 O' CLOCK POSITION
