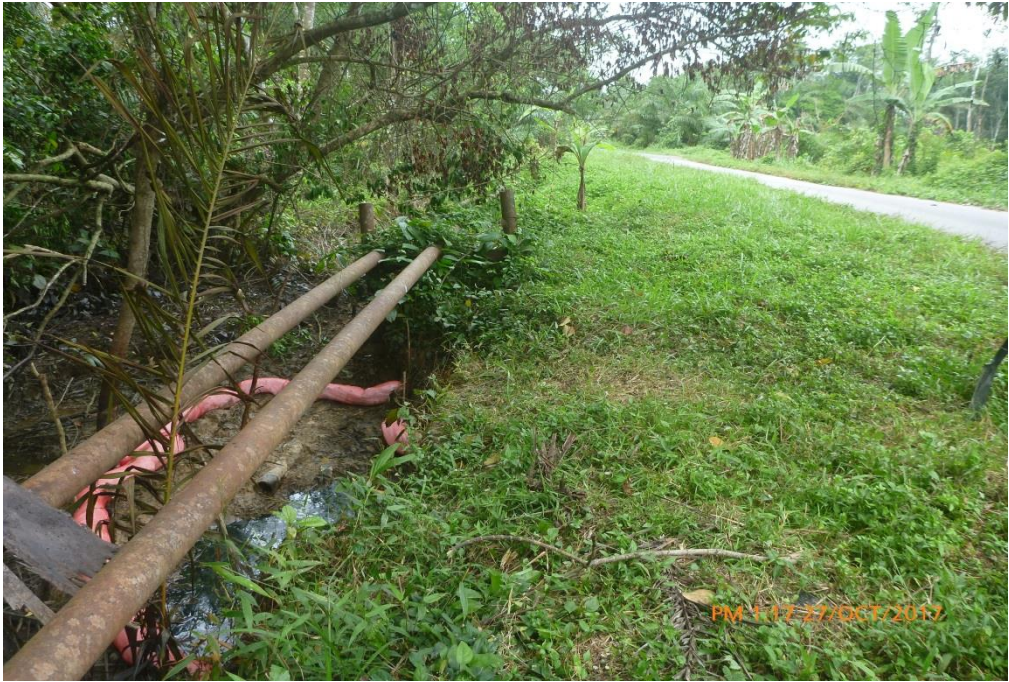
Overview: Part of spill impact on 4" Adibawa Well 23 Disused Flowline at Edagberi Better Land. Picture was taken during Joint Investigation of 27th October 2017.

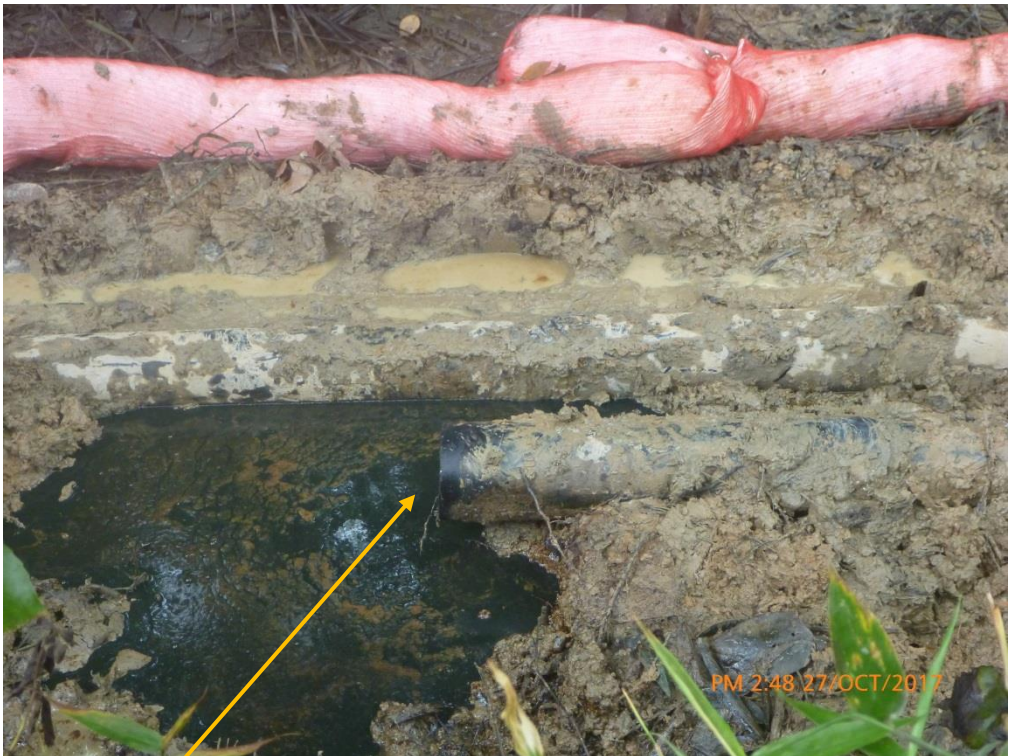
Close-up: Missing Flowline on 4" Adibawa Well 23 Disused Flowline at Edagberi Better Land. Picture was taken during Joint Investigation of 27th October 2017.
