# JOINT INVESTIGATION REPORT

INCIDENT NO: 1954972 JIV report S/N: 0904

1. Spill incident Number: 1954972 2. Type of incident\* OIL SPILL  
3. Name of Location 4" ADIBAWA WELL 23 DISUSED FLOWLINE  
FAAGBERI  
4. Name of nearest community BETTER LAND 5. State: RIVERS 6. LGA AIJOADA WEST  
7. Type of Production facility/Installation OIL FLOWLINE  
8. Asset owner/District SPDC / CENTRAL HUB

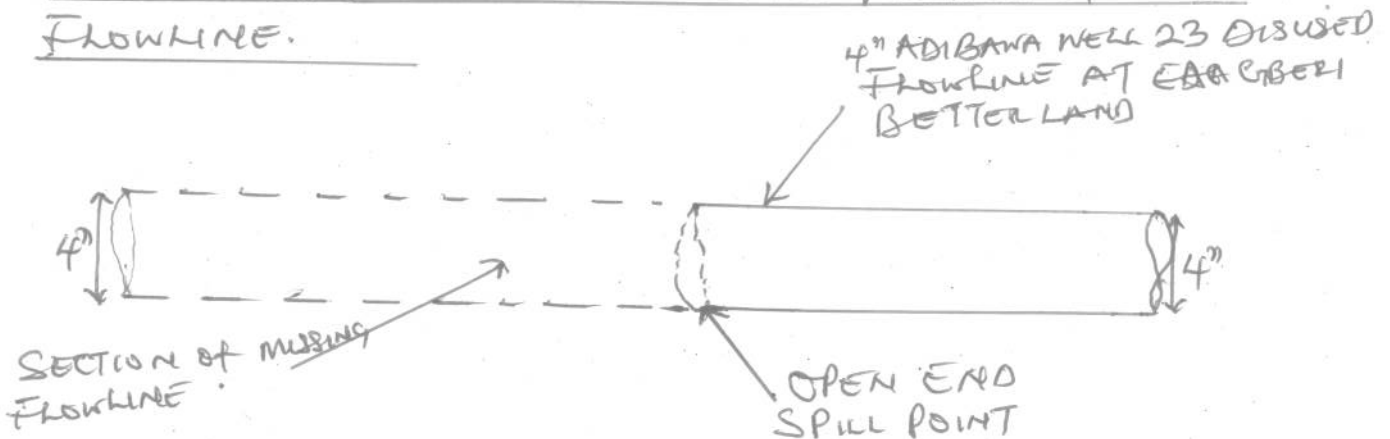
ON ARRIVAL AT SITE JOINT INVESTIGATION TEAM OBSERVED MISSING FLOWLINE

A SECTION OF 4" ADIBAWA WELL 23 DISUSED FLOWLINE AT EDACIBERI BETTER LAND SHOWING THE POSITION OF MISSING FLOWLINE.
