JOINT INVESTIGATION REPORT

INCIDENT NO: 1925458 JIV report S/N: 09??

1. Spill incident Number: 1925458 2. Type of incident* OIL SPILL
3. Name of Location 28" BOMU - BONNY TRANS NIGER PIPELINE ROW.
4. Name of nearest community OGBONGA FOREST (OLEMA) State: RIVERS 6. LGA BONNY
7. Type of Production facility/Installation OIL PIPELINE
8. Asset owner/District THE SHELL PETROLEUM DEVELOPMENT COMPANY OF NIGERIA LIMITED.

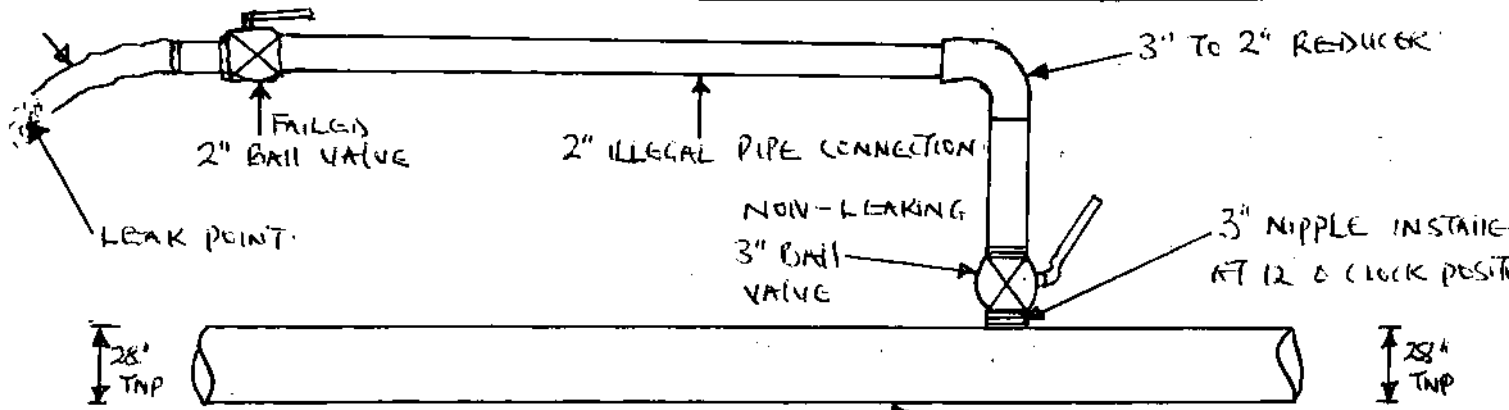
SECTIONAL VIEW OF 28" BOMU - BONNY TRANS NIGER PIPELINE AT OGBONGA FERRIS

SHOWING:- LEAK FROM 2" BALL VALVE CONNECTED AT A DISTANCE AWAY FROM THE 3" NON-LEAKING ILLEGAL THEFT POINT.

LEAK IS FROM THE CRUDE OIL THEFT LINE - BUT CONNECTION TO AN
 WHICH
 ILLEGAL REFINERY SITE, FAILED AT A POINT OUTSIDE THE 28" BENU
 -BONNY TRANS NIGER PIPELINE RIGHT OF WAY (ROW) AND SPILLED
 INTO THE MANGROVE, THEN THE OIL FLOWED WITH TIDE AND
 AND IMPACTED THE 28" TNP ROW AT OGBENGA FOREST, THE
 WHICH IS
 LOCATION OF THE NON LEAKING THEFT POINT WITH FID 1761237.

TEMPERARY REPAIR WORK BY SCREW CAPPING AND CRUDE OIL RECOVERY WORK ONGOING
