# JOINT INVESTIGATION REPORT

INCIDENT NO: 1934452 JIV report S/N: 1102

1. Spill incident Number: 1934452 2. Type of incident\* OIL SPILL  
3. Name of Location AGBAYA WELL-1 WELLHEAD  
4. Name of nearest community AGBAYAMA 5. State: BAYELSA 6. LGA EKEREMOR  
7. Type of Production facility/Installation WELLHEAD  
8. Asset owner/District THE SHELL PETROLEUM DEVELOPMENT COMPANY OF NIGERIA LIMITED/SWAMP WEST

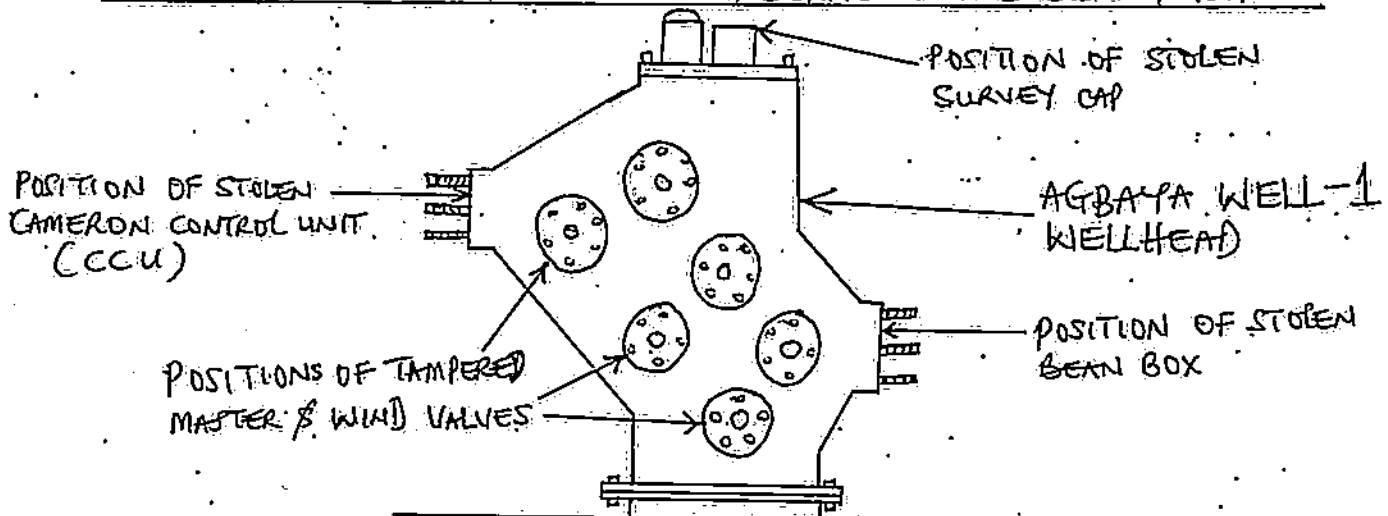
Additional observations around the spill point: DURING ASSESSMENT, THE JOINT INVESTIGATION TEAM OBSERVED THAT THE WELLHEAD SURVEY CAP, BEAN BOX AND CAMERON CONTROL UNIT ON AGBAYA WELL-1 WERE REMOVED BY UNKNOWN PERSONS. THE MASTER AND WIND VALVES WERE ALSO TAMPERED WITH. THE LEAK HAS STOPPED AS AT THE TIME OF THIS INVESTIGATION.

| <input type="checkbox"/> Corrosion | <input checked="" type="checkbox"/> Others(specify) <u>ILLEGAL REMOVAL OF CCU, BEAN BOX AND SURVEY CAP.</u> | |

SECTION OF AGBAYA WELL-1 WELLHEAD AT AGBAYAMA AXIS, SHOWING POSITIONS OF STOLEN CCU, BEAN BOX AND SURVEY CAP.
