JOINT INVESTIGATION REPORT

INCIDENT NO: 1938178 JIV report S/N: 0929

1. Spill incident Number: 1938178 2. Type of incident* OIL SPILL
3. Name of Location 16" EGBEMA - ASSA (TRUNKLINE) PIPELINE
4. Name of nearest community OBILE 5. State: IMO 6. LGA OHAJI/ EGBEMA
7. Type of Production facility/Installation OIL PIPELINE
8. Asset owner/District THE SHELL PETROLEUM DEVELOPMENT COMPANY OF NIGERIA LIMITED.

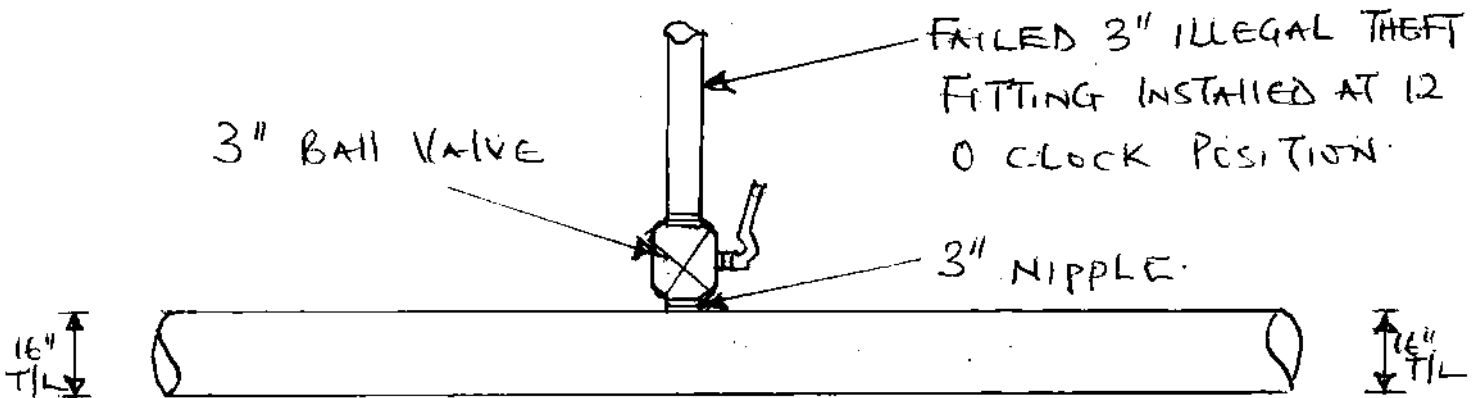
Additional observations around the spill point: THE JOINT INVESTIGATION TEAM SAW SAND BAGS USED TO CONCEAL THE ILLEGAL THEFT POINT.

| <input checked="" type="checkbox"/> Failed Weld-on illegal hot tap valve | <input type="checkbox"/> Failed Clamp, | <input type="checkbox"/> Missing Pipeline/Flowline |
| <input checked="" type="checkbox"/> Crude oil theft (illegal bunkering) point, | <input type="checkbox"/> Saver-pit over flow | <input type="checkbox"/> Third party tampering with Clamp |

SECTIONAL VIEW OF 16" EGBEMA - ASSA (TRUNKLINE) PIPELINE AT OBILE
SHOWING A FAILED 3" WELD-ON ILLEGAL HOT TAP VALVE.

REPAIR WORK BY CLAMPING AND OIL SPILL RECOVERY
WORK ONGOING.

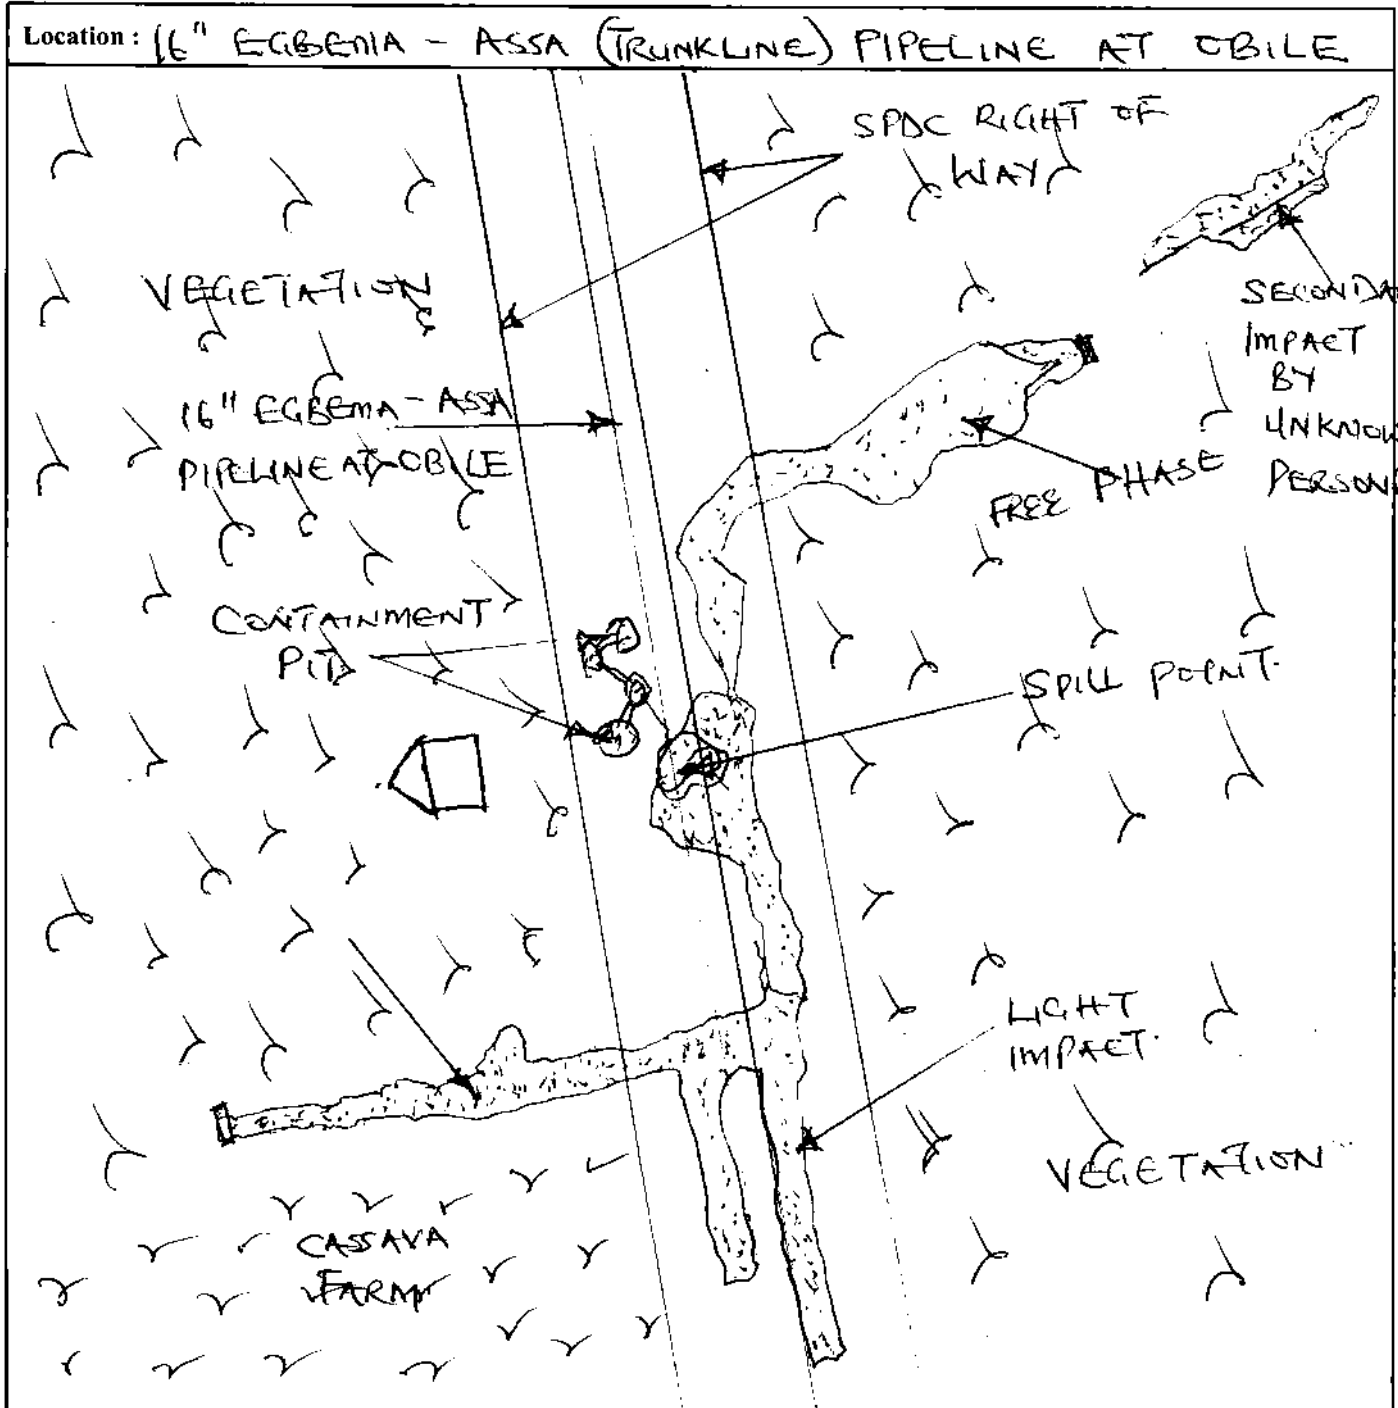
f. Appendix 1: Overview sketch of the site

- Total calculated area of impact 0.31 HA
- Impact within R.O.W YES
- Impact outside R.O.W YES
