JOINT INVESTIGATION REPORT

INCIDENT NO: 2054409 JIV report S/N: 1042

1. Spill incident Number: 2054409 2. Type of incident* OIL SPILL
3. Name of Location 28" BOMU - BONNY TRANS NIGER PIPELINE
4. Name of nearest community PATRICK WATER SIDE 5. State: RIVERS 6. LGA GOKANA
7. Type of Production facility/Installation OIL PIPELINE
8. Asset owner/District THE SHELL PETROLEUM DEVELOPMENT COMPANY OF NIGERIA LIMITED PIPELINE

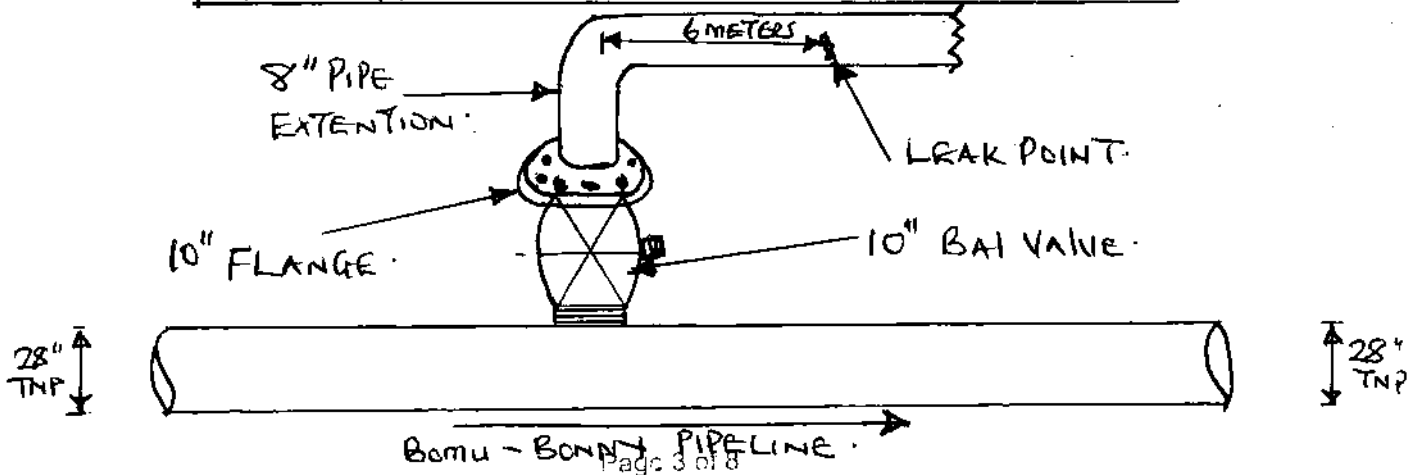
Additional observations around the spill point: THE JOINT INVESTIGATION TEAM OBSERVED AN 8" PIPE EXTENSION CONNECTED TO THE 10" THEFT FITTING WITH A LEAK POINT 6 METERS AWAY FROM THE 28" BOMU - BONNY TRANS NIGER PIPELINE AT PATRICK WATER SIDE.

SECTIONAL VIEW OF 28" BOMU - BONNY TRANS NIGER PIPELINE AT PATRICK

WATER SIDE SHOWING: LEAKING 10" BALL VALVE ILLEGAL THEFT FITTING INSTALLED AT 12 O'CLOCK POSITION.

RECOVERY WORK ONGOING WHILE REPAIR WORK BY BLIND
FLAYGONG COMPLETED.
