# JOINT INVESTIGATION REPORT

INCIDENT NO: 2053130 JIV report S/N: 1039

1. Spill incident Number: 2053130 2. Type of incident\* OIL SPILL  
3. Name of Location 8" ISIMIRI - IMO GATE PIPELINE  
4. Name of nearest community OBIAKPU 5. State: ABIA 6. LGA UKWA-WEST  
7. Type of Production facility/Installation OIL PIPELINE  
8. Asset owner/District THE SHELL PETROLEUM DEVELOPMENT COMPANY OF NIGERIA LIMITED/ PIPELINE

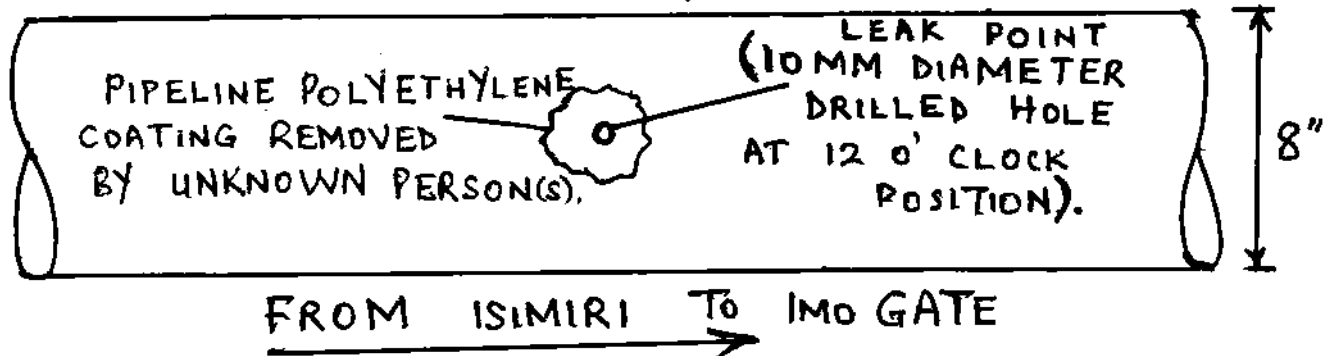
Additional observations around the spill point: UPON EXPOSURE OF THE SPILL POINT, A SECTION OF THE SURROUNDING PIPELINE POLYETHYLENE COATING WAS OBSERVED TO HAVE BEEN REMOVED BY UNKNOWN PERSON(S).

SECTION OF 8" ISIMIRI — IMO GATE PIPELINE  
AT OBIAKPU SHOWING POSITION OF LEAK  
POINT (DRILLED HOLE)
