JOINT INVESTIGATION REPORT

INCIDENT NO: 2067472 JIV report S/N: 1052

1. Spill incident Number: 2067472 2. Type of incident* OIL SPILL
3. Name of Location 14" OKORDIA - RUMUEKPE (TRUNKLINE) PIPELINE
4. Name of nearest community UKPELEDE 5. State: RIVERS 6. LGA ATHOADA WEST
7. Type of Production facility/Installation OIL PIPELINE
8. Asset owner/District THE SHELL PETROLEUM DEVELOPMENT COMPANY OF NIGERIA LIMITED / PIPELINE

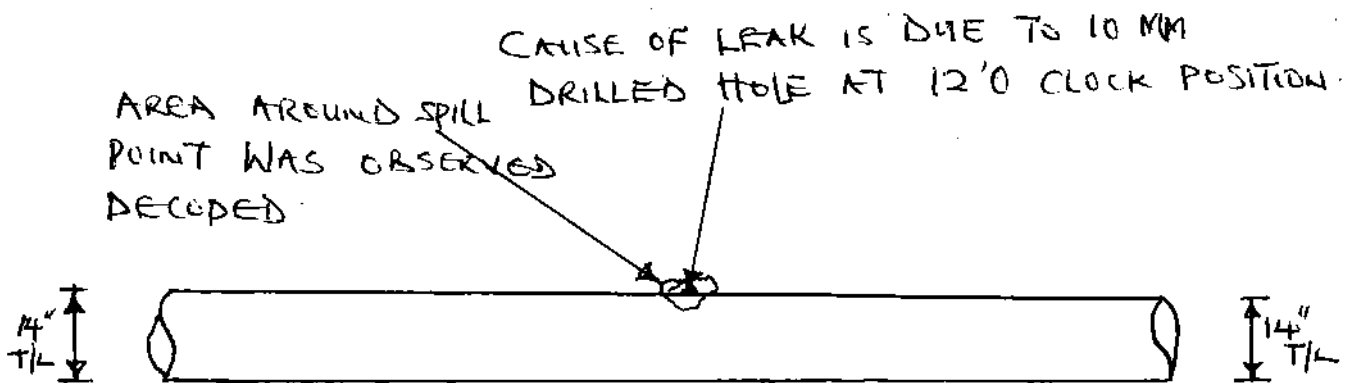
SECTIONAL VIEW OF 14" OKORDIA - RUMUEKPE (TRUNKLINE) PIPELINE AT UKPELEDE SHOWING! - LEAK DUE TO 10MM DRILLED HOLE

RECOVERY AND REPAIR WORK BY CLAMPING
ARE ON-GOING
