JOINT INVESTIGATION REPORT

INCIDENT NO: 2068083 JIV report S/N: 1036

1. Spill incident Number: 2068083 2. Type of incident* OIL SPILL
3. Name of Location 16" EGBEMA - ASSA PIPELINE
4. Name of nearest community EKUGBA 5. State: IMO 6. LGA OHAJI/ESBEMA
7. Type of Production facility/Installation OIL PIPELINE
8. Asset owner/District THE SHELL PETROLEUM DEVELOPMENT COMPANY OF NIGERIA
KTD (S PDC)/PIPELINE

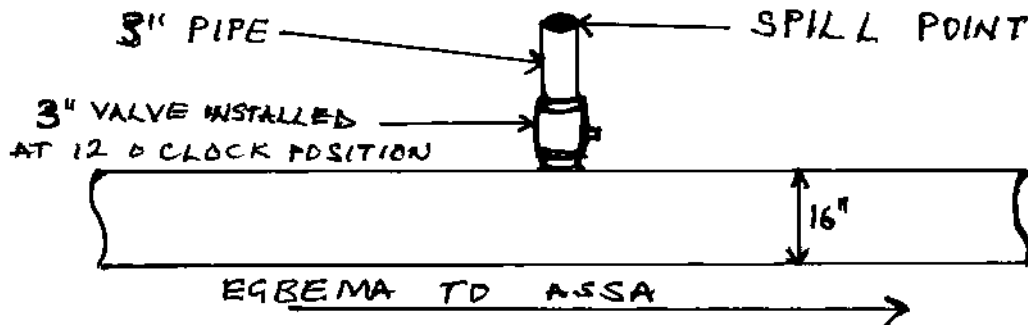
Additional observations around the spill point: THE TEAM OBSERVED A 3" VALVE
CRUDE THEFT POINT INSTALLED AT 12 O'CLOCK
POSITIONS.

| <input checked="" type="checkbox"/> Crude oil theft (illegal bunkering) point. | <input type="checkbox"/> Saver-pit over flow | <input type="checkbox"/> Third party tampering with Clamp |

A SECTION OF 16" EGBEMA - ASSA PIPELINE AT EKUGBA SHOWING A 3" VALVE CRUDE THEFT POINT INSTALLED AT 12 O'CLOCK POSITION BY UNKNOWN PERSONS

REPAIR BY CLAMPING
