JOINT INVESTIGATION REPORT

INCIDENT NO: 2067178 JIV report S/N: 1073

1. Spill incident Number: 2067178 2. Type of incident* OIL SPILL
3. Name of Location 24" TRANS - RAMOS PIPELINE
4. Name of nearest community ODIMODI 5. State: DELTA 6. LGA BURUTU
7. Type of Production facility/Installation OIL PIPELINE
8. Asset owner/District THE SHELL PETROLEUM DEVELOPMENT COMPANY
OF NIGERIA LIMITED / PIPELINE

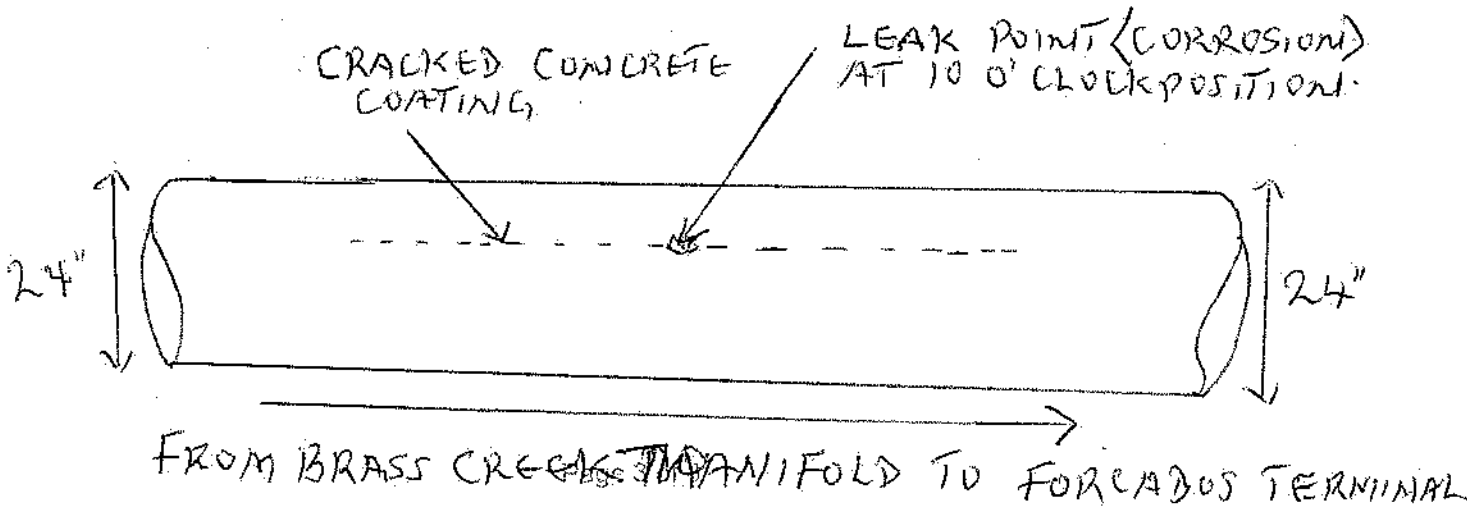
OIL STAIN ALONG CRACKED CONCRETE COATING WAS OBSERVED.

| <input checked="" type="checkbox"/> Corrosion | <input type="checkbox"/> Others(specify) _____ | |

SECTION OF 24" TRANS - RAMOS PIPELINE AT ODIKIODI
SHOWING CORROSION AT 10 O'CLOCK POSITION

REPAIR WORK ONGOING
