JOINT INVESTIGATION REPORT

INCIDENT NO: 2065593 JIV report S/N:1087

1. Spill incident Number: 2065593
2. Type of incident* OIL SPILL
3. Name of Location 20TH KOLD-CREEK-RUMUKPE TRUNK LINE
4. Name of nearest community IMOGHO-RUMUKPE
5. State: RIVERS
6. LGA ENTOMHUA
7. Type of Production facility/Installation OIL PIPELINE
8. Asset owner/District THE SHELL PETROLEUM DEVELOPMENT COMPANY OF NIGERIA LIMITED / PIPELINE

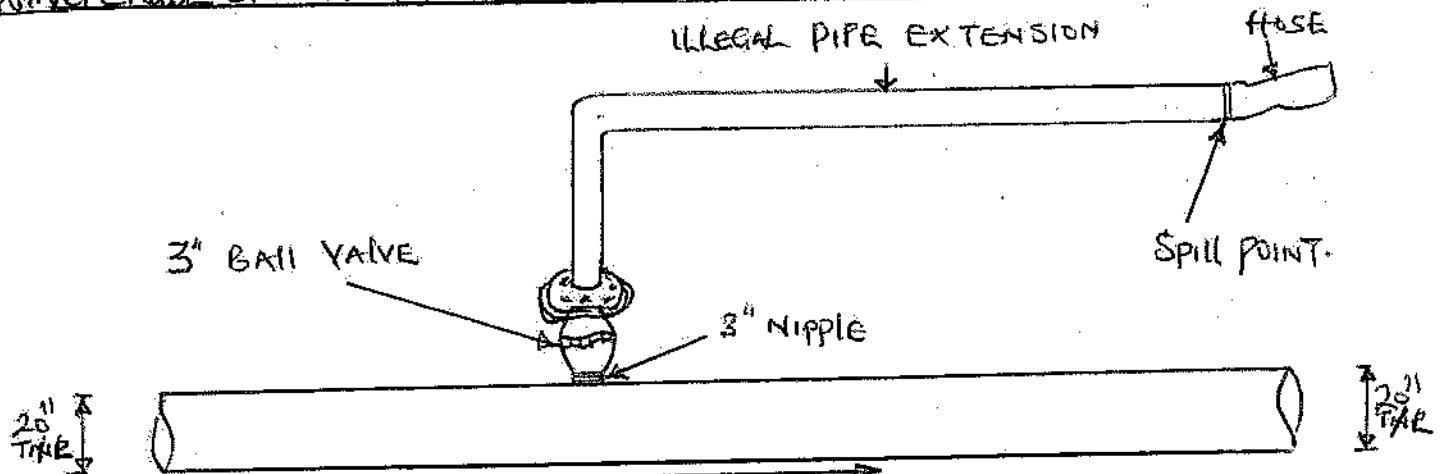
| <input checked="" type="checkbox"/> Crude oil theft (illegal bunkering) point, | <input type="checkbox"/> Saver-pit over flow | <input type="checkbox"/> Third party tampering with Clamp, |

| <input checked="" type="checkbox"/> Third party interference (Sabotage) | <input checked="" type="checkbox"/> Crude theft | <input type="checkbox"/> Line theft | <input type="checkbox"/> Accidental 3 rd party damage |

SECTION VIEW OF 20" KOLD CREEK-RUMUEKPE TRUNK LINE AT IMOGLI RUMUEKPE
SHOWING CRUDE OIL THEFT POINT INSTALLED AT 12° CLOCK POSITION.

REPAIR WORK BY BLIND FLANGING
