JOINT INVESTIGATION REPORT

INCIDENT NO: 2066951 JIV report S/N: 1072

1. Spill incident Number: 2066951 2. Type of incident* OIL SPILL
3. Name of Location 24" TRANS - RAMOS PIPELINE
4. Name of nearest community ODIMODI 5. State: DELTA 6. LGA BURUTU
7. Type of Production facility/Installation OIL PIPELINE
8. Asset owner/District THE SHELL PETROLEUM DEVELOPMENT COMPANY
OF NIGERIA LIMITED / PIPELINE

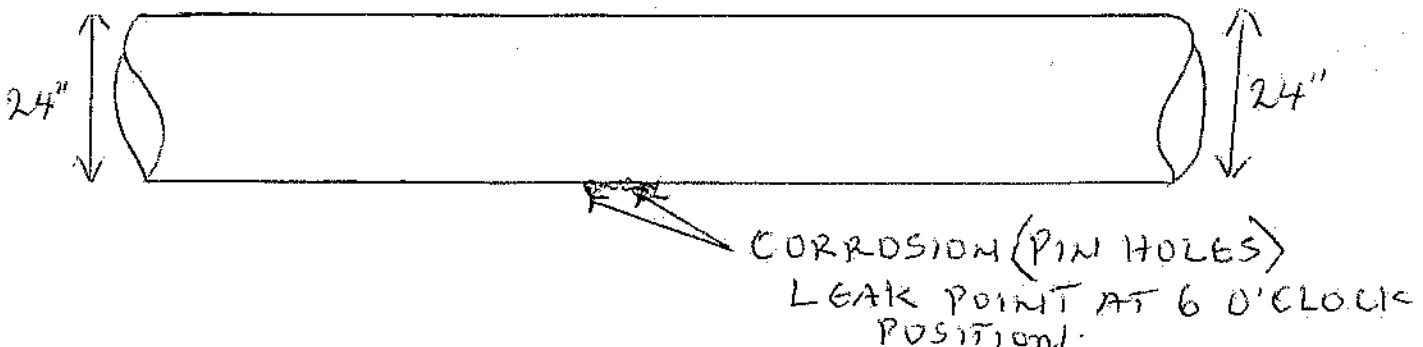
| <input checked="" type="checkbox"/> Corrosion | <input type="checkbox"/> Others(specify) _____ | |

SECTION OF 24" TRANS - RAMOS PIPELINE AT ODIMODI
SHOWING CORROSION AT 6 O'CLOCK POSITION.

RECOVERY AND REPAIR ACTIVITIES ARE ONGOING
