JOINT INVESTIGATION REPORT

INCIDENT NO: 2066027 JIV report S/N: 1134

1. Spill incident Number: 2066027 2. Type of incident* OIL SPILL
3. Name of Location 24" TRANS - RAMOS PIPELINE
4. Name of nearest community ODIMODI 5. State: DELTA 6. LGA BURUTU
7. Type of Production facility/Installation OIL PIPELINE
8. Asset owner/District THE SHELL PETROLEUM DEVELOPMENT COMPANY OF NIGERIA LIMITED / PIPELINE

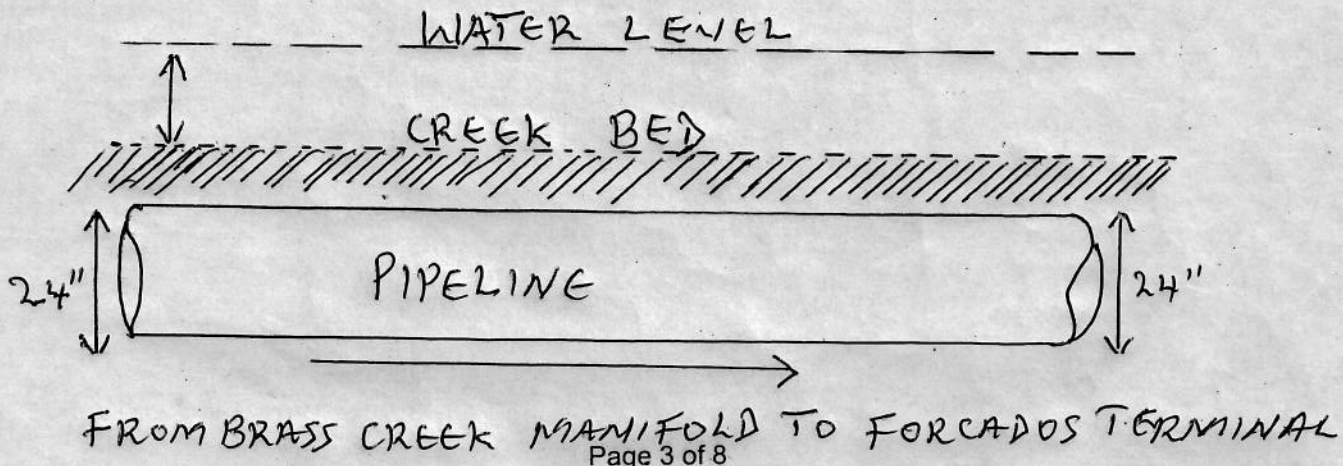
Additional observations around the spill point: AS AT TIME OF JOINT INVESTIGATION THE AFFECTED SECTION OF THE PIPELINE WAS COMPLETELY SUBMERGED IN WATER BECAUSE THE INCIDENT HAPPENED AT A CREEK CROSSING.

SECTION OF 24" TRANS - RAMOS PIPELINE AT ODIMODI SHOWING POSITION OF AFFECTED SUBMERGED PART OF THE PIPELINE
