JOINT INVESTIGATION REPORT

INCIDENT NO: 2135006 JIV report S/N: 1139

1. Spill incident Number: 2135006 2. Type of incident* OIL SPILL
3. Name of Location 20" OTUMARA - ESCRAVOS PIPELINE
4. Name of nearest community UGBOGUNGUN 5. State: DELTA 6. LGA WARRI SOUTH-WEST
7. Type of Production facility/Installation OIL PIPELINE
8. Asset owner/District THE SHELL PETROLEUM DEVELOPMENT COMPANY OF NIGERIA LIMITED / PIPELINE

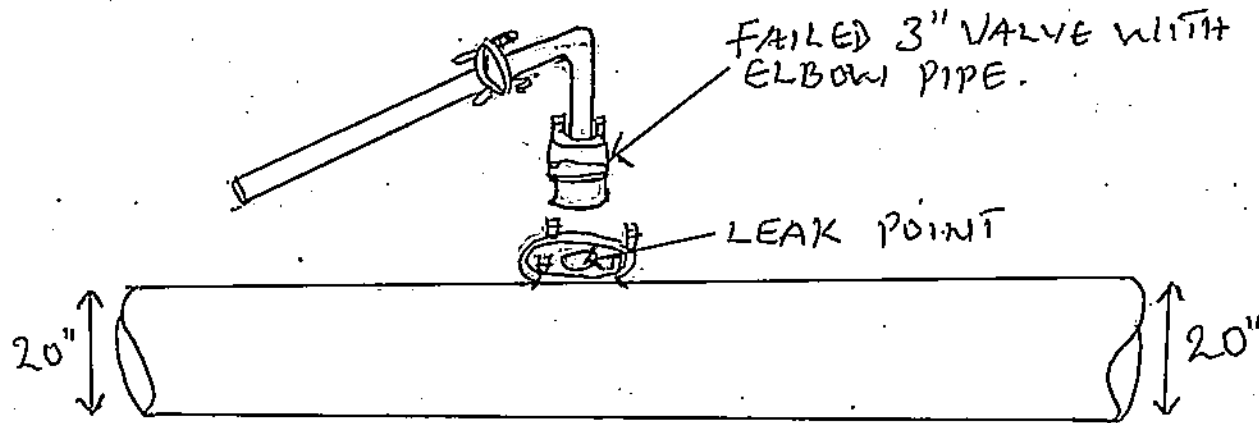
Additional observations around the spill point: THE JOINT INVESTIGATION TEAM OBSERVED A FAILED 3" VALVE ILLEGALLY ATTACHED TO THE 20" OTUMARA - ESCRAVOS PIPELINE AT 12 O' CLOCK POSITION.

SECTION OF 20" OTUMARA - ESCRANOS PIPELINE AT USBOEGUNBUNA SHOWING CRUDE OIL THEFT POINT AT 12 O'CLOCK POSITION.
