JOINT INVESTIGATION REPORT

INCIDENT NO: 2149613 JIV report S/N:0032

1. Spill incident Number: 2149613 2. Type of incident* OIL SPILL/FIRE
3. Name of Location 12" IMO RIVER - OGALE PIPELINE
4. Name of nearest community OGALE 5. State: RIVERS 6. LGA ELEME
7. Type of Production facility/Installation OIL PIPELINE
8. Asset owner/District THE SHELL PETROLEUM DEVELOPMENT COMPANY OF NIGERIA
ATA (SPDC)/PIPELINE

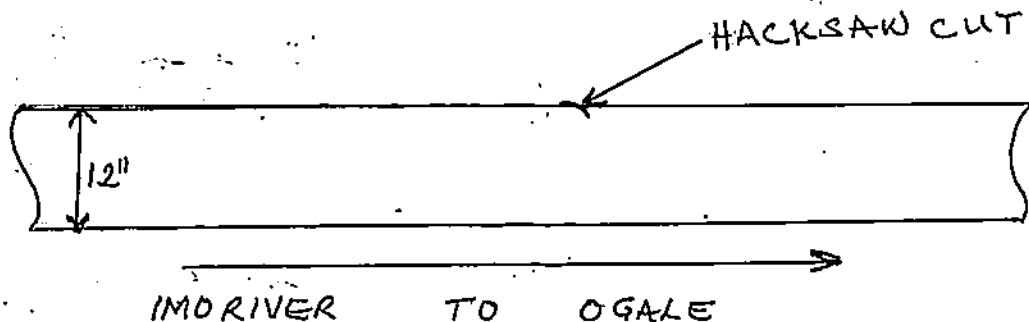
Additional observations around the spill point: THE JOINT INVESTIGATION TEAM SAW AN HACKSAW CUT AT 12 O'CLOCK POSITION. THE TEAM SAW BURNT SPILL POINT.

E. GRAPHIC DESCRIPTION OF LEAK POINT (while detailed report of the leak point should be contained in the leak report, overview sketch of the site should be added as an appendix 1) A SECTION OF 12" IMD RIVER - OGALE PIPELINE AT OGALE SHOWING 15MM HACK SAW CUT AT 12' O'CLOCK POSITION BY UNKNOWN PERSONS.

LEAK REPAIR BY CLAMPING
